# KOREA Engineering & Construction

Beyond safety, Delivering Greater Value,  
Korea E&C, the Integrated  
Reinforcement Science Leader

## Technology Overview

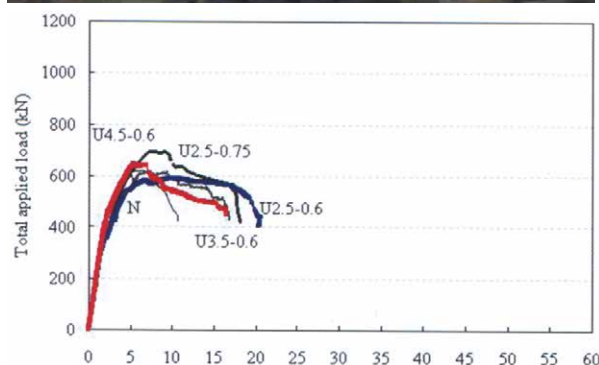
↑ The shear reinforcement effect of settle-on-the-side-of-beam(U type) T-shape beam (Brittle Failure)

※ As the result of testing with the T-shape beam identical with the actual field condition, the settle-on-the-side-of-beam method has almost no shear reinforcement effect.

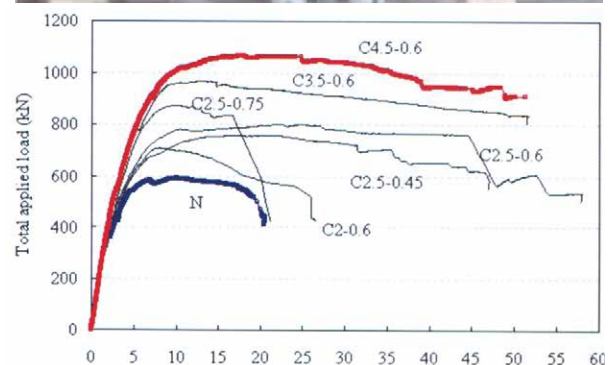
↑ The shear reinforcement effect of beam close-type-settlement (Closed type) T-shape beam (Ductile Failure)

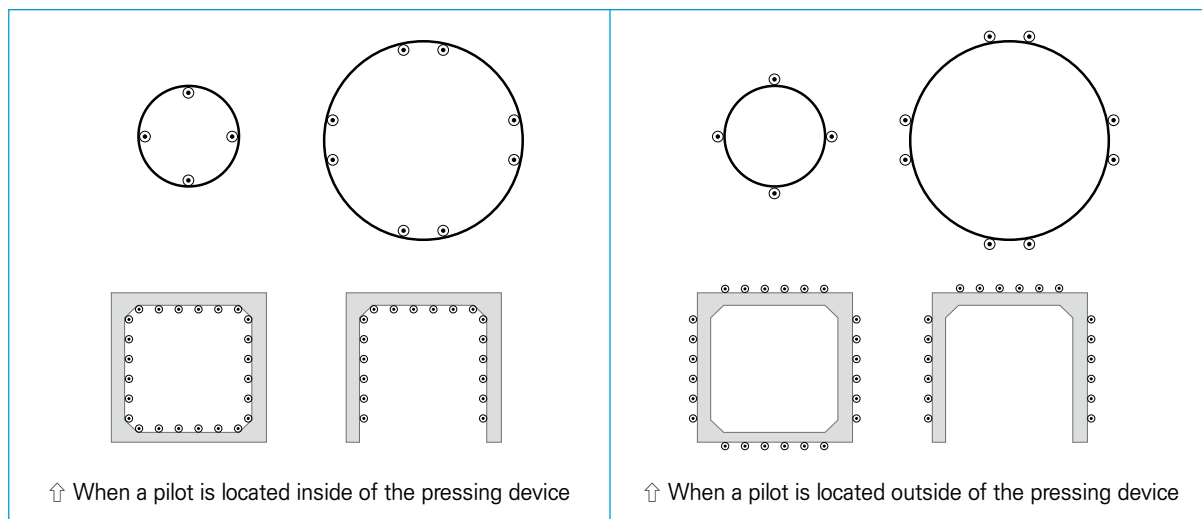
For a steel pipe (above) and concrete box (below), the number of pilots increases according to the frictional resistance condition.

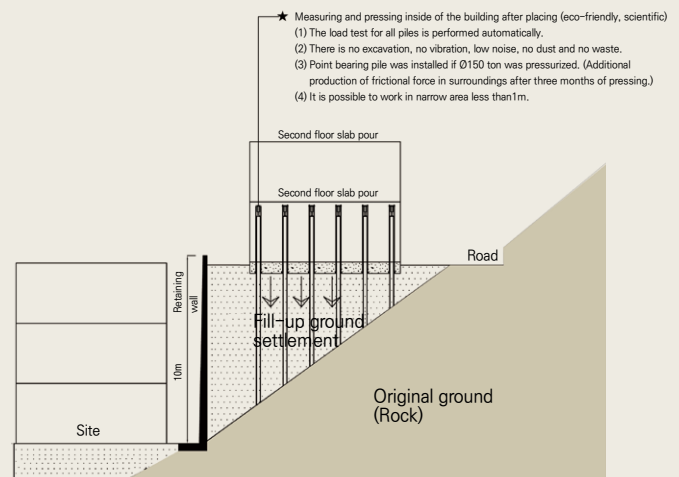
### Construction procedure chart after piling

Measuring and individual pressing

Measuring and pressing piles and pressurizing them simultaneously

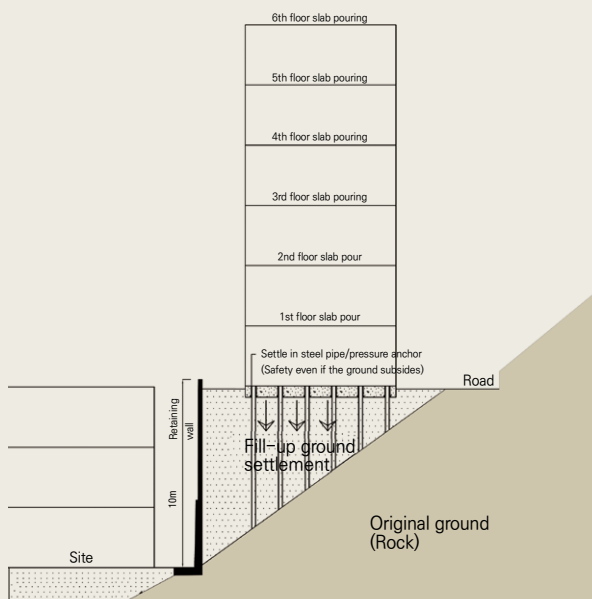
Pressed pile installation-exposure on the foundation

Pressed pile installation-hiding at the foundation

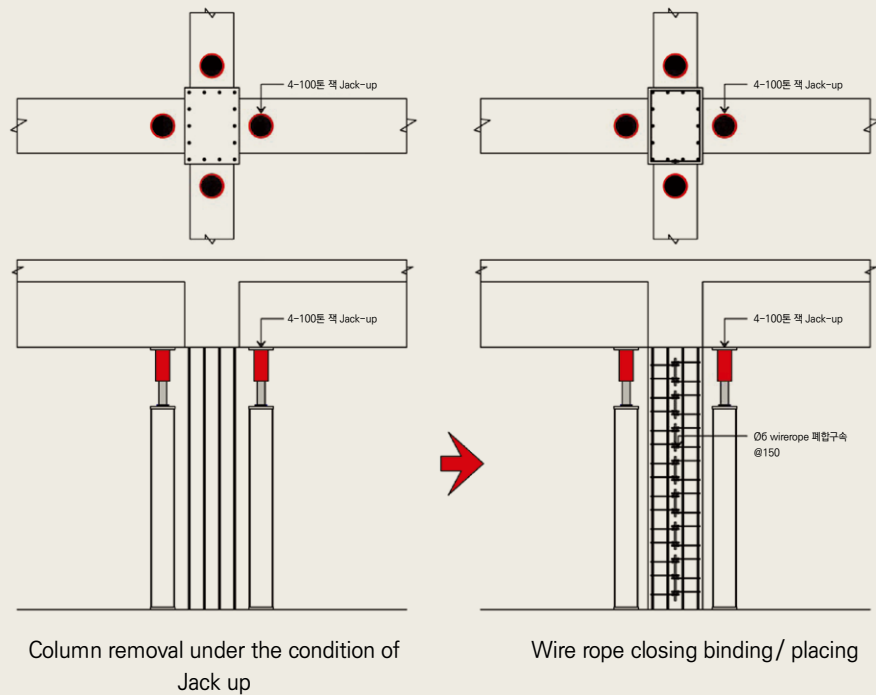
Reinforcement concept chart

It was an accident that ceiling beam slanted due to pressurized and destroyed columns in underground parking lot columns, and vertical fraction occurred. A gap was made in horizontal hoop due to lack of concrete strength, and vertical steel bar was bent. Sloping beam was jacked up as the original condition, and concrete with lack of strength was removed. Bent vertical steel bar was reinforced by using new one, gapped hoop was removed, and concrete was placed again by binding bolt/nut connected to wire rope. It was estimated that concrete with lack of strength influenced beam placing. The beam was reinforced by using steel sheet, and the surface of concrete condition of the beam reinforced by the steel sheet was not able to be observed. Steel sheet reinforced by using epoxy adhesion has a possibility to delaminate by itself when temperature changes because its coefficient of linear expansion is very different from the concrete's.

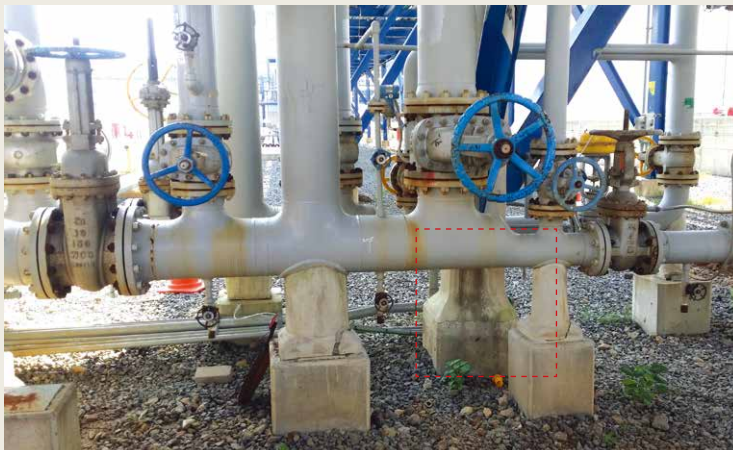
Column foundation reinforcement within dotted line

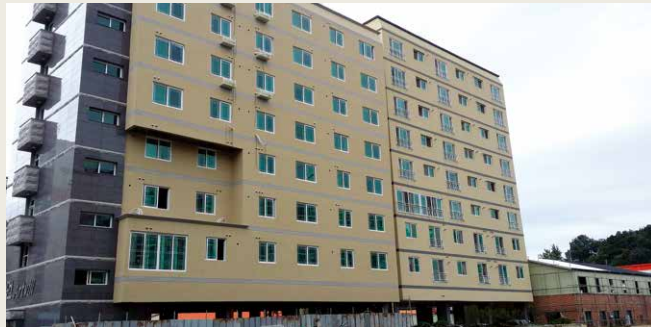
Two buildings are shown distortedly due to column punching settlement.

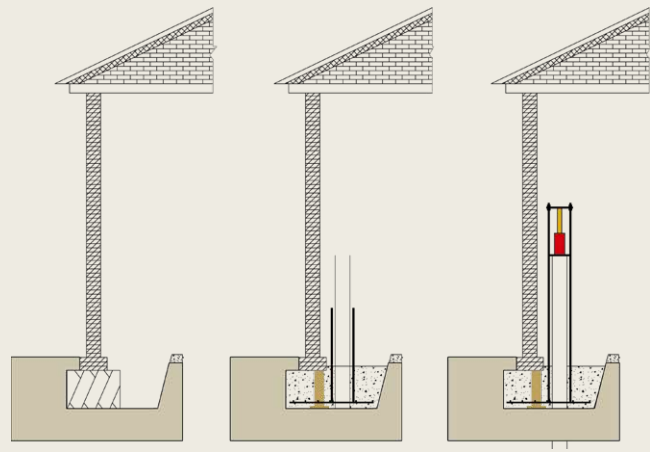
Boulder-foundation change
