# KOREA Engineering & Construction

Beyond safety, Delivering Greater Value,  
Korea E&C, the Integrated  
Reinforcement Science Leader

## Technology Overview

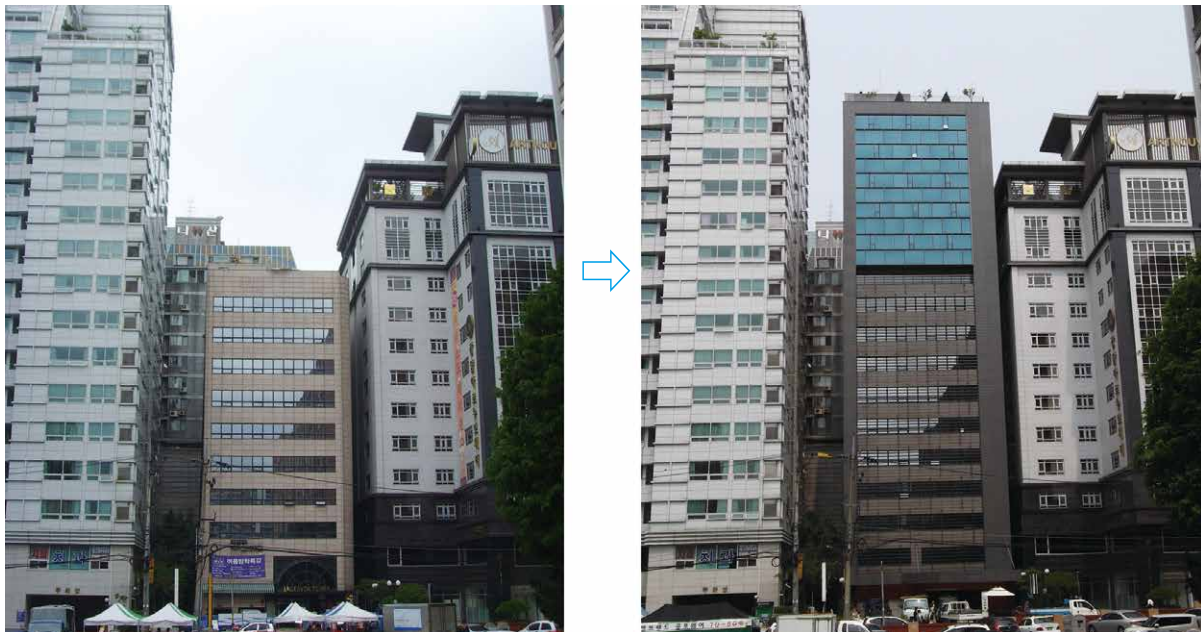
Reinforced the foundation of the existing building with 10 stories and extended vertically to building with 15 stories.(2010, Seoul)

It is the technology which extends an existing building upward from the rooftop after reinforcing the foundation and other structures using Jack Pile without occupants leaving the building.

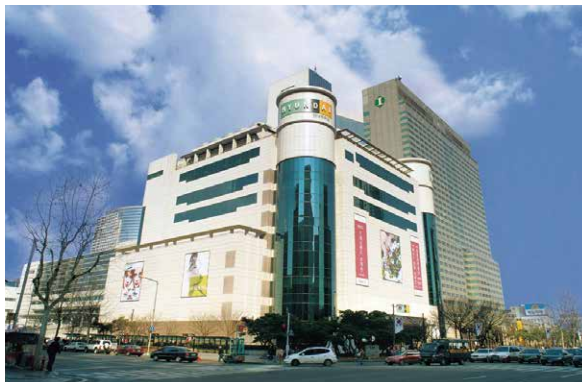
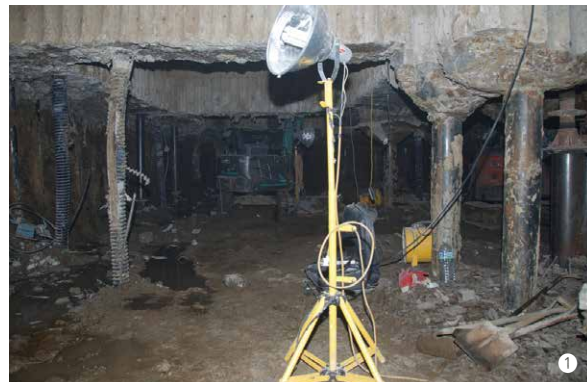
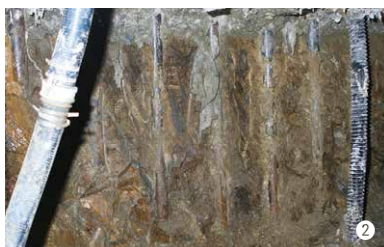
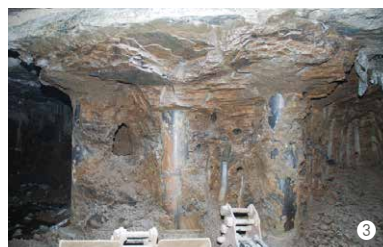
- ① excavated state under the B4 floor.
- ② steel-pipe nail earth retaining wall
- ③ 160 tons pressurization pile is pressed
- ④ elevator pit underground extension

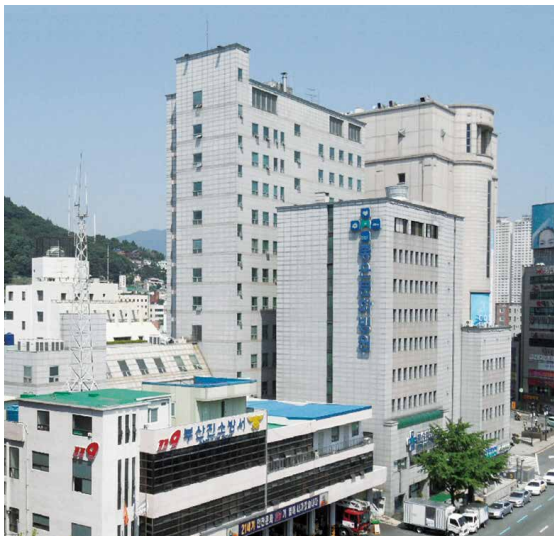
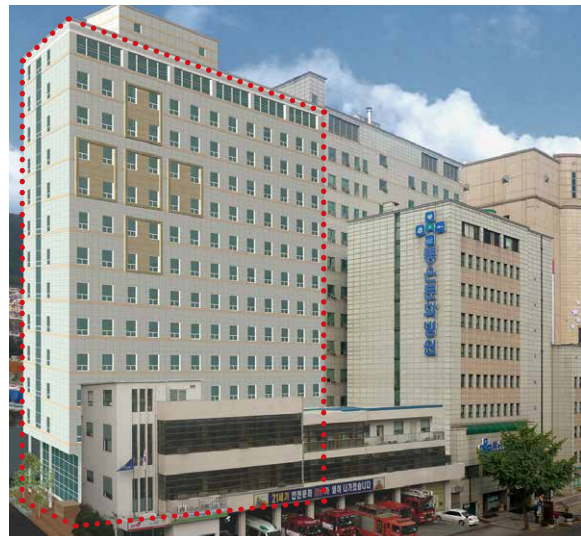
Extended the existing hospital building which had one-story underground and five above the ground into two-story below and fourteen above the ground

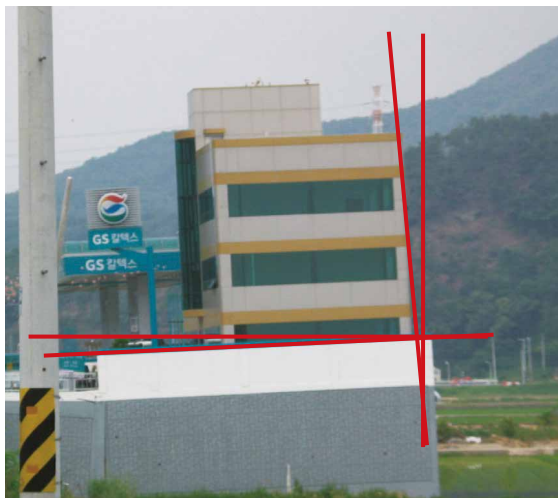
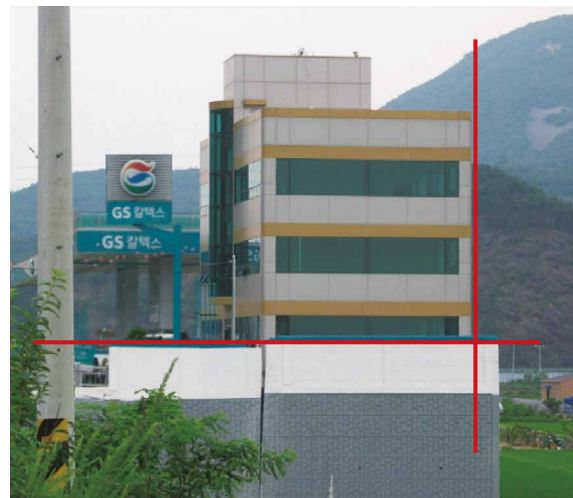
Before/ $\phi$ 400PHC construction grade E disparity settlement → After/ Jack Pile press reinforcement grade A restored.

※ The case in the picture above was successfully completed on the boulder store layers which had been unable to be penetrated by concrete pile driving equipment.

After a building construction is completed, if a structure gets tilted(disparity settlement), the usability and the safety is significantly damaged. Korea E&C can restore a building which is a subject to be demolished by relevant regulation (grade E) to a best structural state (grade A) using Jack Pile. (New Excellent Technology certification No.629, Foundation Reinforcement)

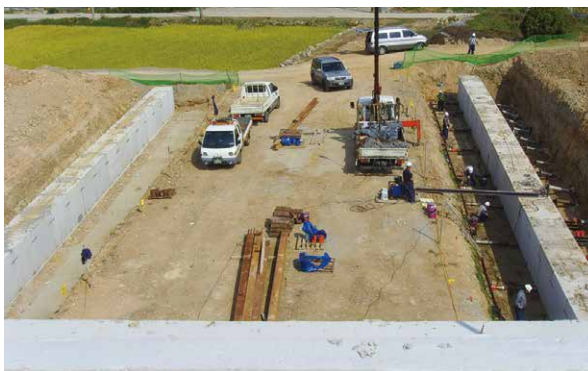
↑ Moving a measurement error PC box

Movement and rotation goes through raising–lifting–moving–lowering process after cutting underground structures such as a foundation, pillar, retaining wall, etc in the state that an existing structure is slightly lifted using Jack Pile. After moving, a pillar is settled in the foundation of a press pile.

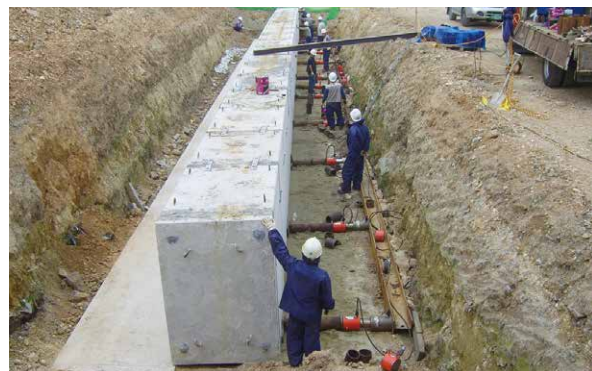
Moving/Rotating Fujian Xiaman in China ⇨

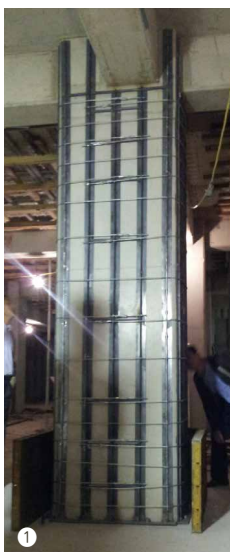
Details of Steel plate Column reinforcement with epoxy bonded

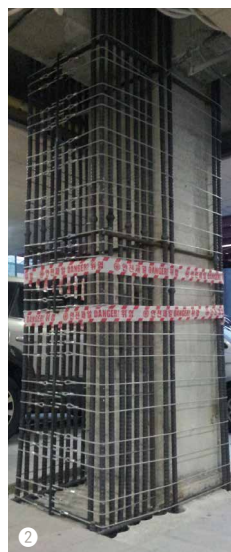
Details of Bolt Tension column reinforcement without bonded

The technology of Korea E&C does not require the process of surfaces chipping and anchor drilling of the current technology. The earthquake resistance capacity and axial force get improved and a column connected with wall is also reinforced easily without cutting, by installing T-shape section steel or reinforcing steel bar on the outside of existing column which is penetrated through slabs of the upper/lower floor and by pre-stressing an eye-bolt connected with a wire-ropes. Also, when this method is applied, a vertical crack caused by tie hoop relaxation which occurs frequently in the H-beam composite column or existing increased section column is perfectly controlled and even buckling of a vertical reinforcing steel is also controlled with this technology, because a vertical reinforcing steel is strongly confined.

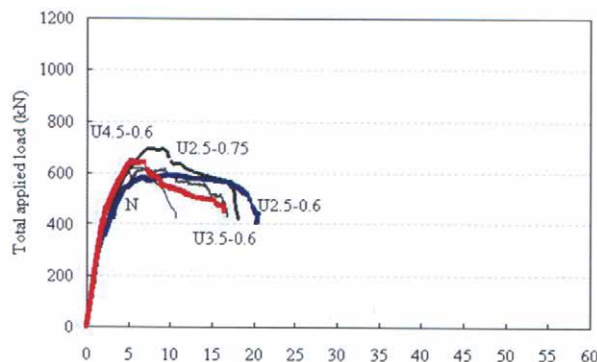
↑ The shear reinforcement effect of settle-on-the-side-of-beam(U type) T-shape beam (Brittle Failure)

※ As the result of testing with the T-shape beam identical with the actual field condition, the settle-on-the-side-of-beam method has almost no shear reinforcement effect.

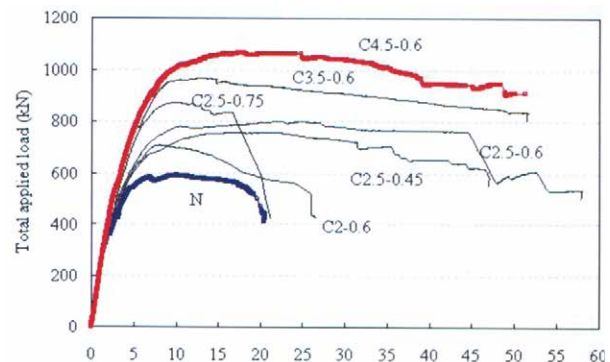
↑ The shear reinforcement effect of beam close-type-settlement (Closed type) T-shape beam (Ductile Failure)

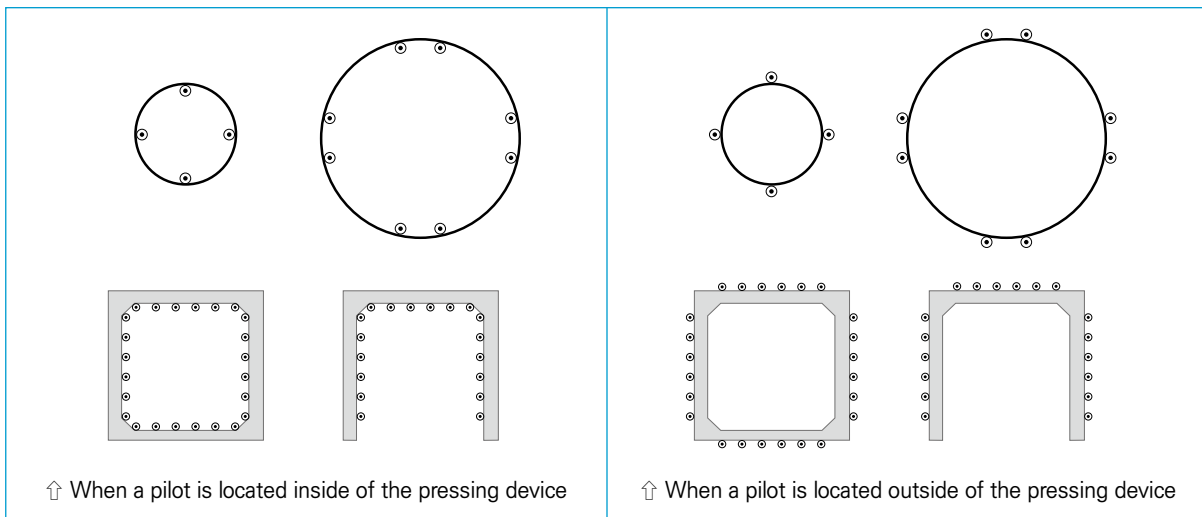
For a steel pipe (above) and concrete box (below), the number of pilots increases according to the frictional resistance condition.

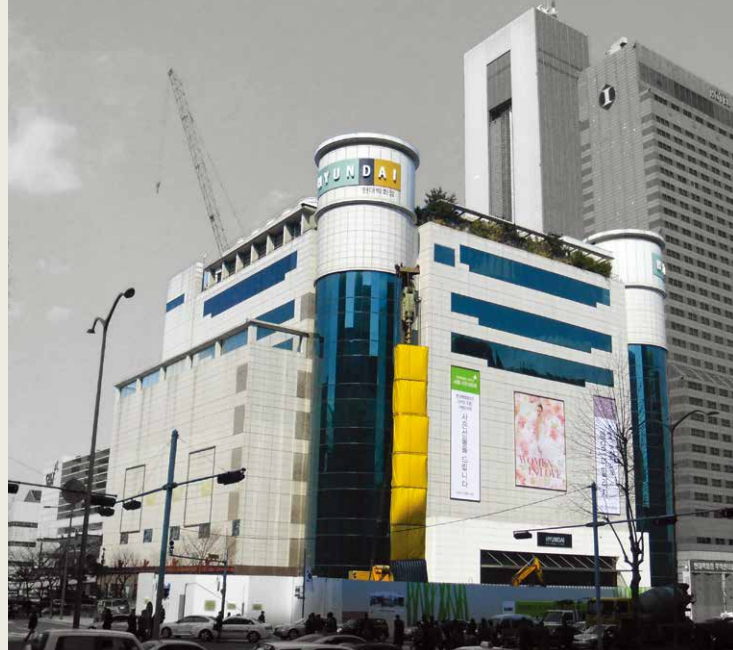
Before construction

Department store operation was performed as usual, and the foundation substructure of the 4th basement level was excavated. The elevator space was extended under the ground, and vertical extension was completed from the 1st floor on the ground to the 10th floor. Column weight of 800ton was used to the foundation reinforcement inside of the 4th basement level, and the foundation reinforcement was performed to the elevator space, then underground extension was completed.

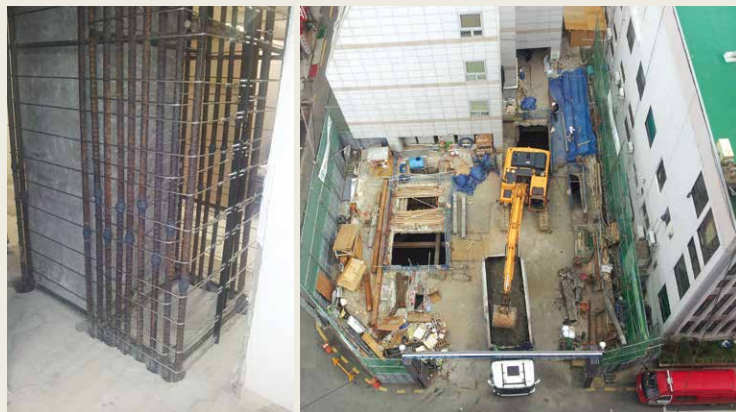
Application of no-adhesive binding column reinforcement construction method without using epoxy adhesion.

It was constructed safely in narrow area by underground excavation (Top Down) after placing the 1st floor bottom.

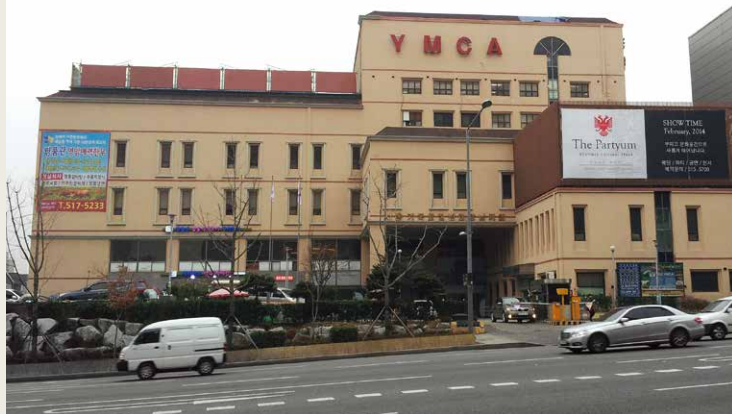
Before construction

It is a case to extend story height for a building located in the center of town without residents' move and removal. The columns were cut by applying structure raise technology and not removing auditorium with area 20m×30m and story height 5m, and then it was remodeled as a patium wedding hall with 8m story height. The construction period and cost were reduced, civil complaints were solved, and the value of the building was increased drastically.

**Location** Nonhyeon-dong, Gangnam-gu, Seoul  
**Period** 2014. 01 ~ 02 (It took 2 months.)  
**Extension** Extension of story height 5m → story height 8m (Extension of story height of 3m)  
**Applied construction method**  
Structure raise

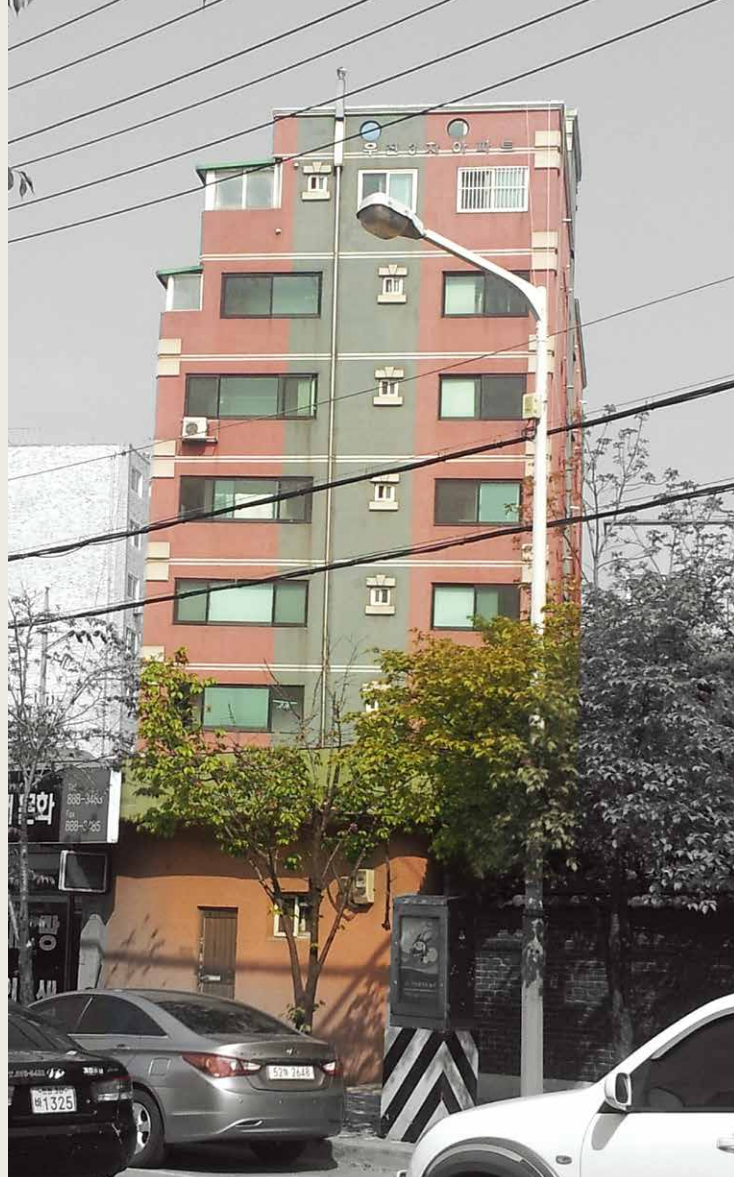
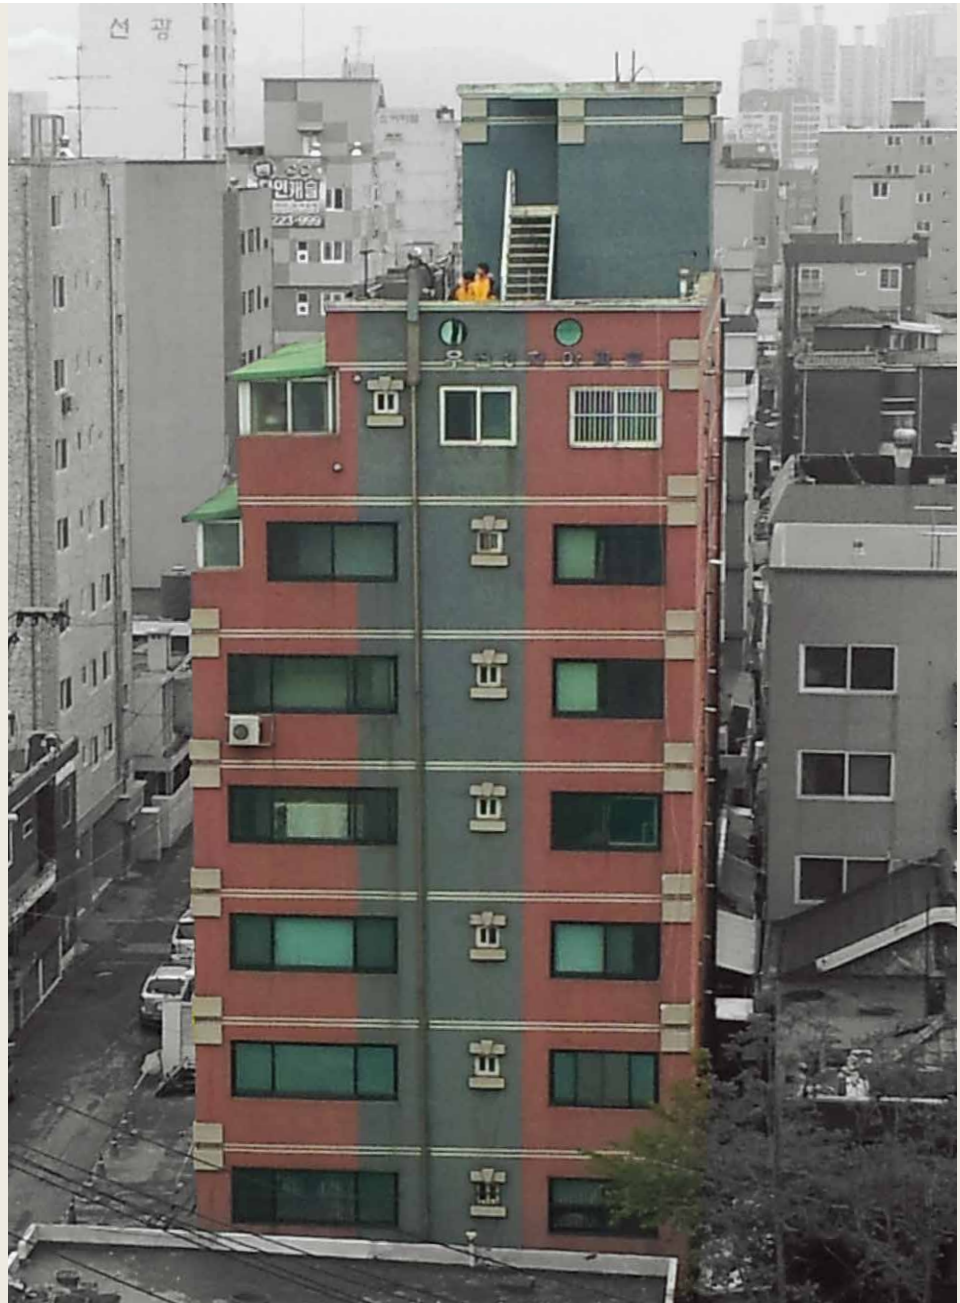
The apartment with eight levels was completed in April, 2003, and the building started to slant before the completion. When the building slanted, the ground reinforcement by inserting cement at the bottom of the sloping part was repeated. However, there was no effect although the inserted cement flowed to the next house and the building slanted more and more. The slope was 1/46 before lifting it up by reinforcing piles in 2013. The slope was more serious level than standard E level which orders removal (standard 1/150) to stop using a building. Solid ground was 10m below, and it was estimated that the inserted cement into the soft ground between them brought about a result to increase the weight of the building not reinforce the ground. As a result of computer structure analysis, it was calculated as the bottom area was 2,570 m<sup>2</sup>, and the weight of the building with eight levels was about 2,500 ton. Fifty five steel piles were divided by each 110 ton, which were measured and reinforced, then secured support ability of 6,000 ton. It was reconstructed as a safe building with slope 1/900, A level (standard 1/750).

Before construction

After construction

Slope and level before and after construction

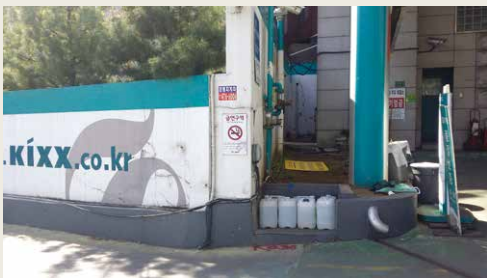
Existing retaining wall

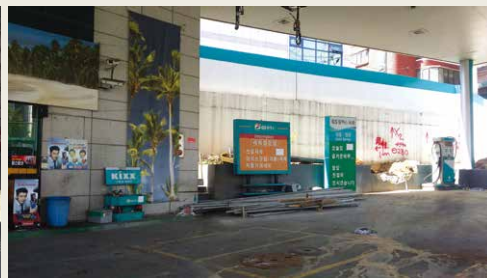
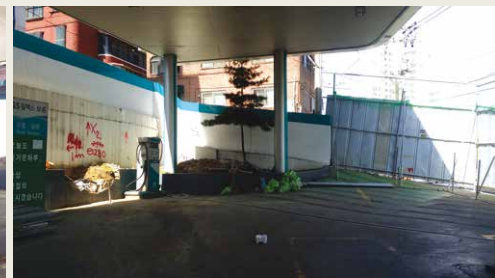
The construction was performed in 0.5m narrow area that it was practically impossible to perform equipment work. It is an underground extension case with total 6m bearing wall as the existing retaining wall was extended to 3m under the ground in very difficult condition with pilaster strip.

### Concept and procedure chart of Sunsa gas station existing retaining wall underground extension

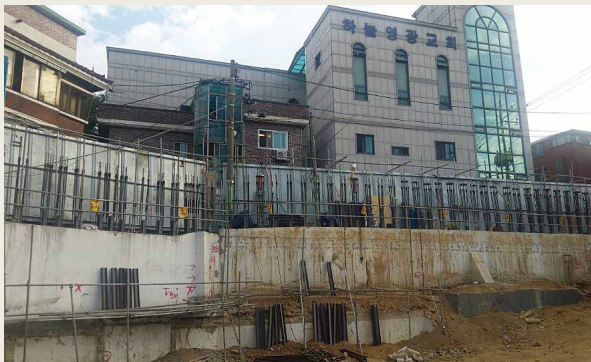
Pressing piles for point bearing and retaining wall in 0.5m area that it was impossible to access equipment.

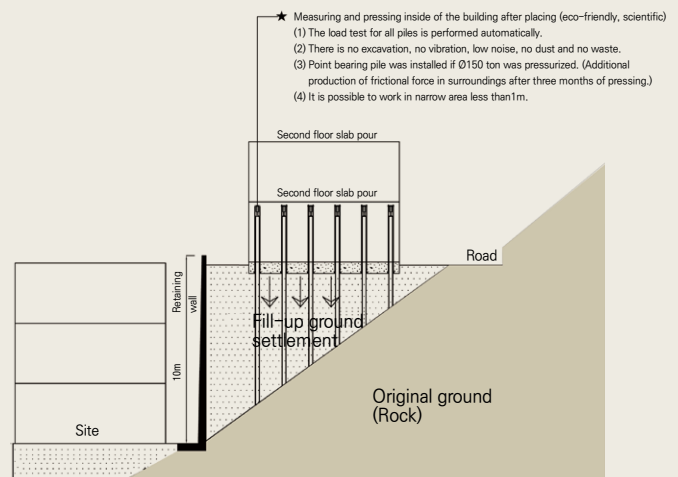
### Construction procedure chart after piling

Measuring and individual pressing

Measuring and pressing piles and pressurizing them simultaneously

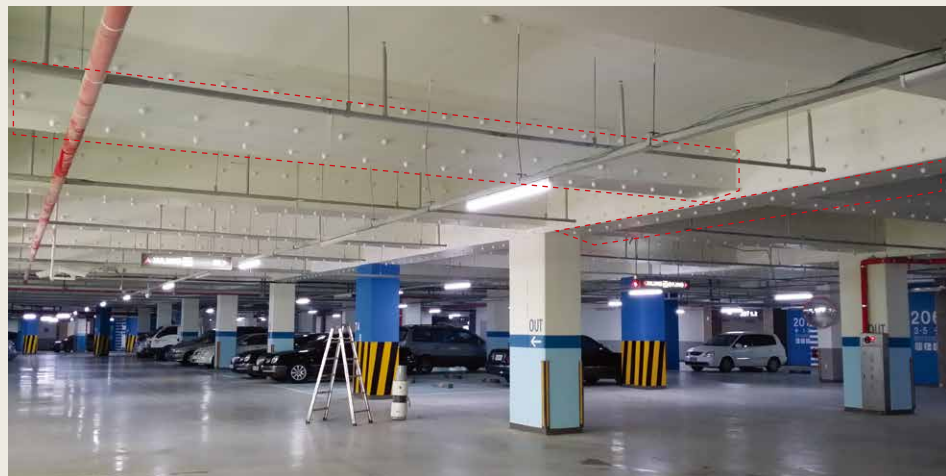
Beam reinforced by steel sheet

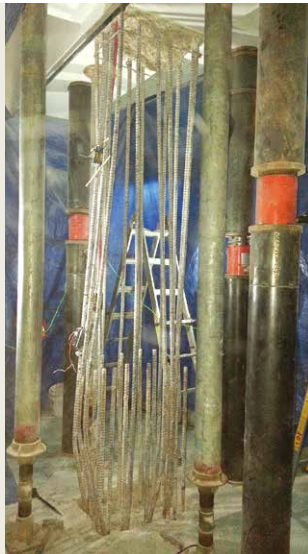
It was an accident that ceiling beam slanted due to pressurized and destroyed columns in underground parking lot columns, and vertical fraction occurred. A gap was made in horizontal hoop due to lack of concrete strength, and vertical steel bar was bent. Sloping beam was jacked up as the original condition, and concrete with lack of strength was removed. Bent vertical steel bar was reinforced by using new one, gapped hoop was removed, and concrete was placed again by binding bolt/nut connected to wire rope. It was estimated that concrete with lack of strength influenced beam placing. The beam was reinforced by using steel sheet, and the surface of concrete condition of the beam reinforced by the steel sheet was not able to be observed. Steel sheet reinforced by using epoxy adhesion has a possibility to delaminate by itself when temperature changes because its coefficient of linear expansion is very different from the concrete's.

Vertical steel bar buckling

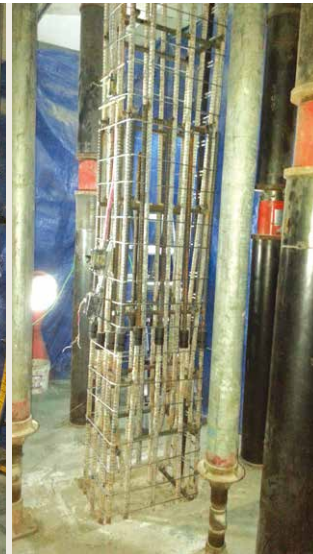
Column steel bar reinforcement/ binding

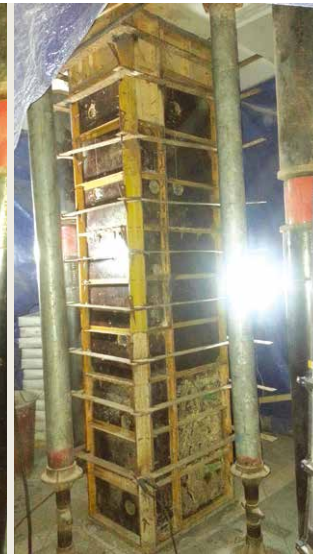
Mold/ placing preparation

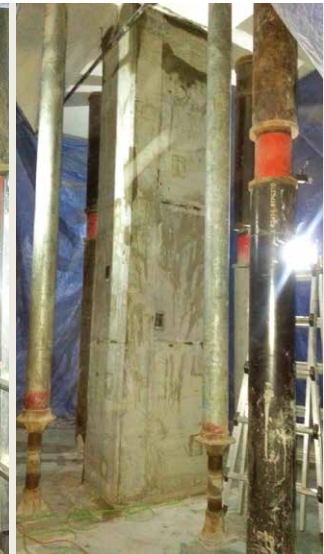
After placing/ reinforcement completion

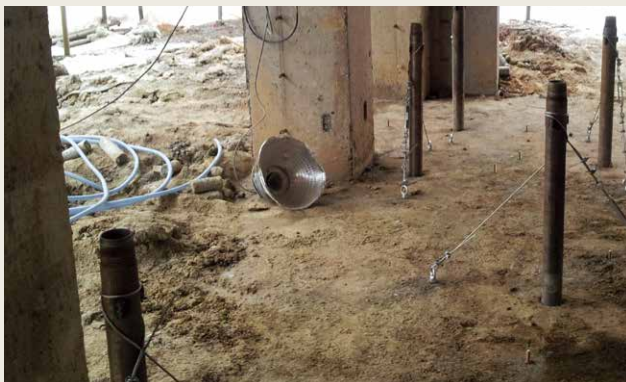
CGS construction method mortar inlet

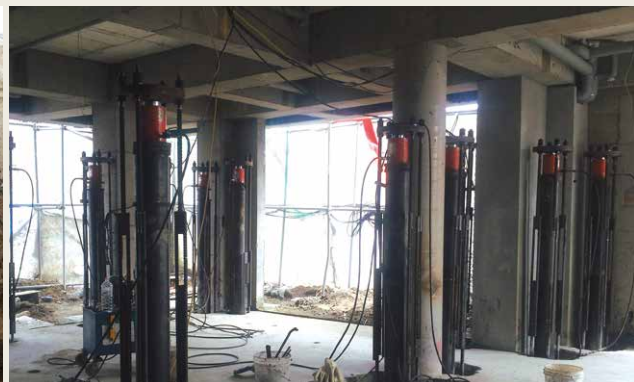
Under construction of pressing piles

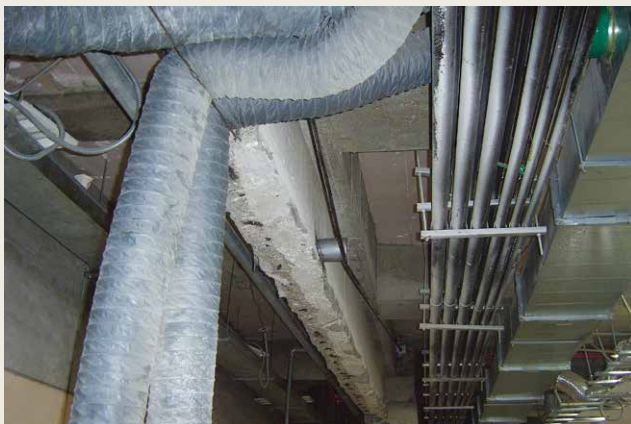
The construction is to remove bearing wall of basement corridor and to extend space of multipurpose hall. Saddle was installed in the center of upper bearing wall, and no-adhesive tension reinforcement to pull at both sides and different materials synthetic column method were applied. It was performed by a principle of reversed suspension bridge.

Strand tension and reinforcement state

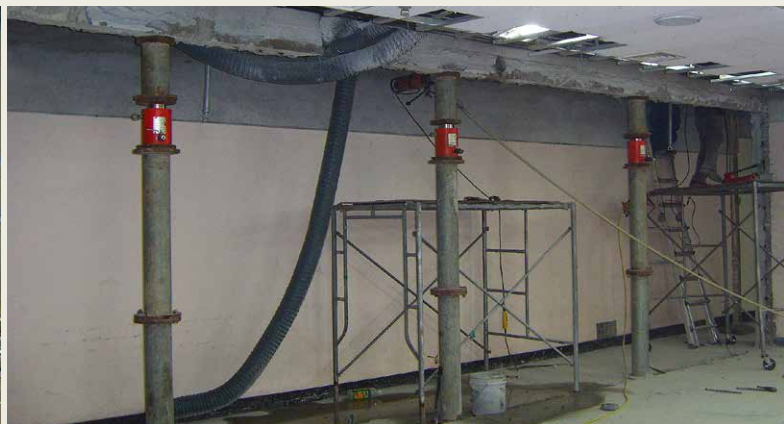
Under construction | removal by supporting as Jack-up pile

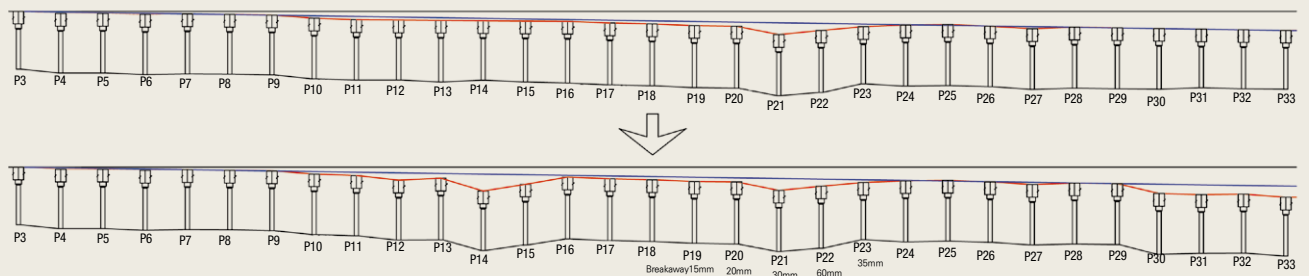
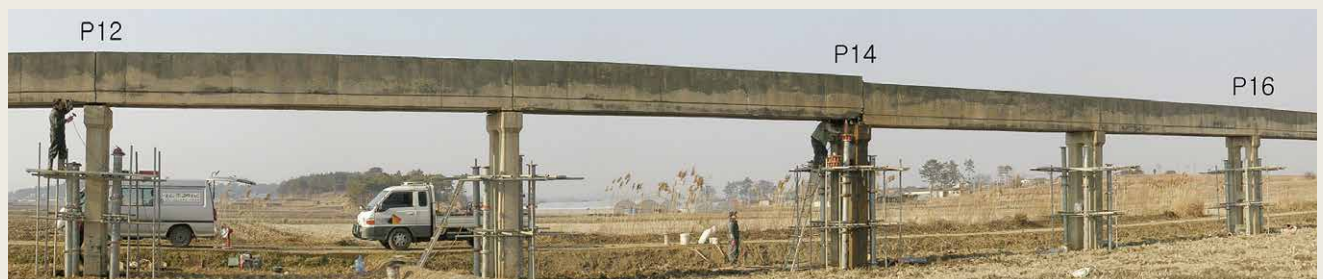
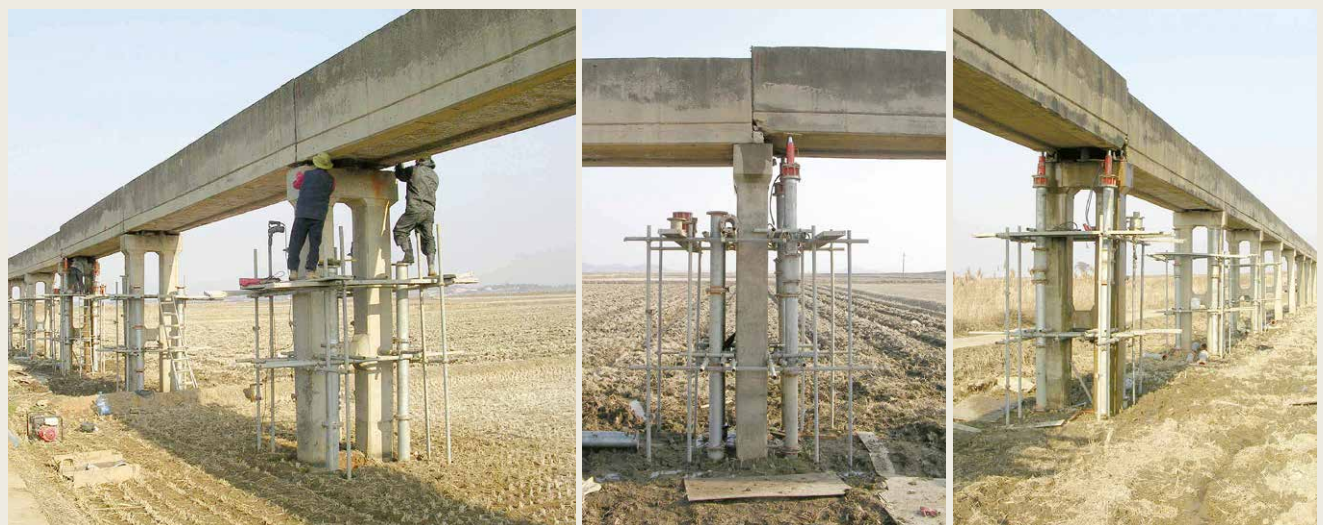
Sloping one part was not repaired, then three parts were increased after 30 months.

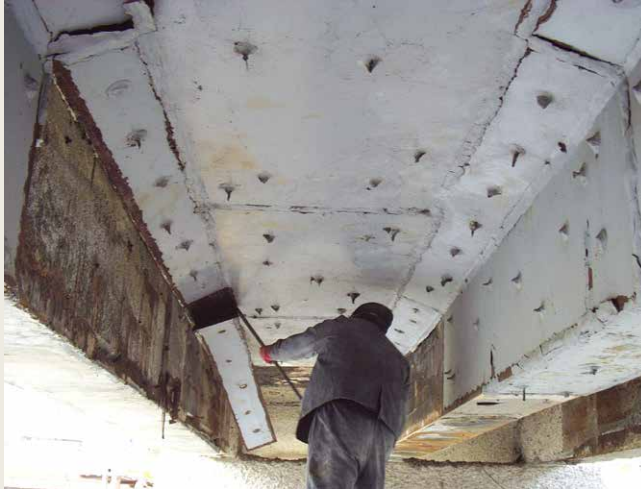
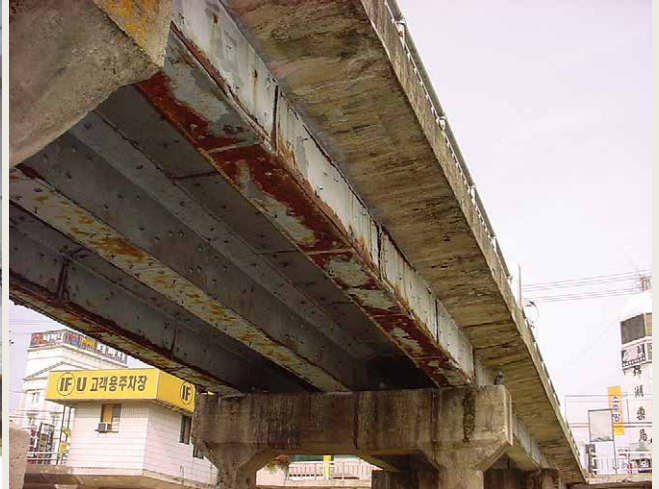
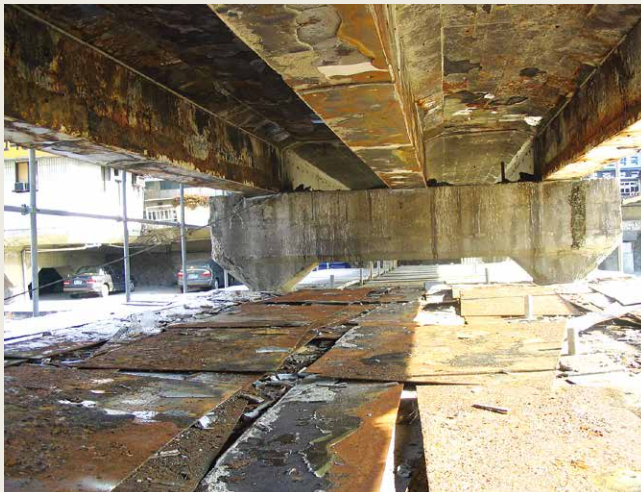
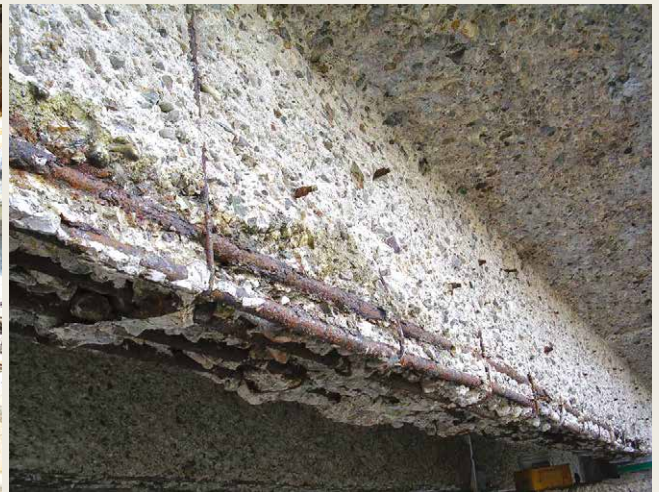
Vehicle traffic was forbidden after a few years of steel sheet reinforcement, and it was expected to remove it due to the risk. Korea E&C contributed construction cost to investigate delamination phenomenon of the epoxy adhesion of steel sheet, and performed maintenance work of Budonggyo with the destiny of removal in 2004. The steel sheet was removed first, and the bridge bearing was replaced. The steel sheet was fallen by itself as cutting bolt, which meant it was already separated and dangled from the concrete long time age, and it was invisible to the naked eye because it was covered by the steel sheet. Because it has different coefficient of linear expansion from the concrete's, the adhesive thing may be fallen by itself even if great power such as earthquake is not applied.

Fallen steel sheet by itself as cutting bolt

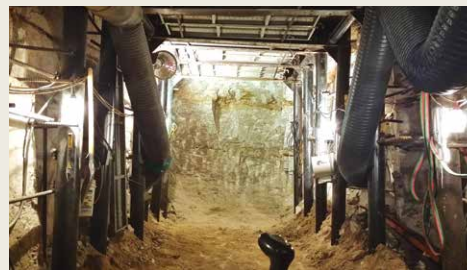
Underground joint hole 90m underground tunnel connection work

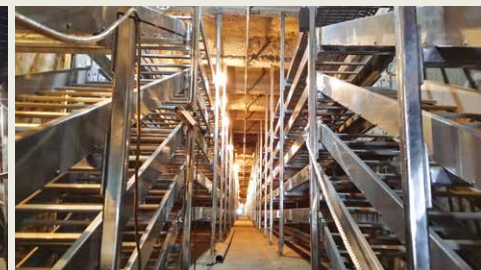
Underground joint hole was completed after connecting the underground tunnel connection

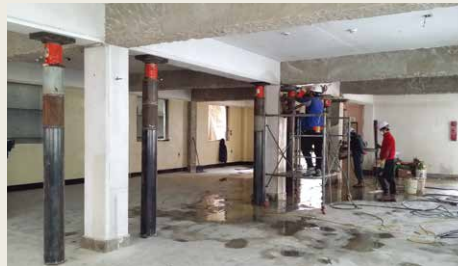
Column removal work by using Jack-up

Although the back building was removed and a way of rebuilding was reviewed in case of the Ulsan hospital, the current area might not be permitted in this case. It might secure additional number of legal parking lots. The space made wide by removing internal column of the building facing a road, and raise extension of a building to place newly the 1st floor was executed by cutting and raising column and wall in the 1st basement level of the back building with five stories above ground and one underground level. The value of the entire building facing road was greatly increased by planning to pass cars in to newly placed 1st floor, and by connecting the front and the back building. It had additional benefit with relieved application of the Building Act in securing parking lot, building area, etc. as remodeling extension not the Building Act of rebuilding.

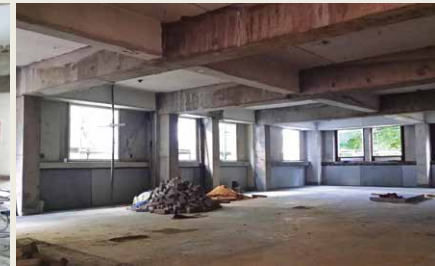
Column removal work was completed

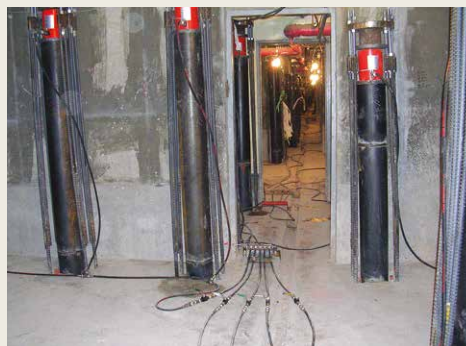
Under construction

High-rise apartment with bottom area 800 m<sup>2</sup>, eighteen stories above ground and one underground level, and 144 households slanted to the condition with slope 1/160, D level even if there was no construction around it after 10 years of its completion. The weight of the sloping apartment was 24,000 ton, and it was reconstructed safely by reinforcing with  $\phi 216$  steel pipe piles of 474 pieces as residents didn't move and elevators were operated as usual, which obtained B level. The foundation thickness of the apartment was 1m, however, the thickness more than 1m brought a result of increasing weight of the building although the foundation of right two households was placed as 2m, and the foundation of one household was placed thickly as 3m to reinforce the ground. The sloping part of the apartment was right side which the foundation thickness was placed more thickly. Reinforcing soft ground by using top foundation brings about a result to accelerate settlement by increasing the weight of the building as the same reason.

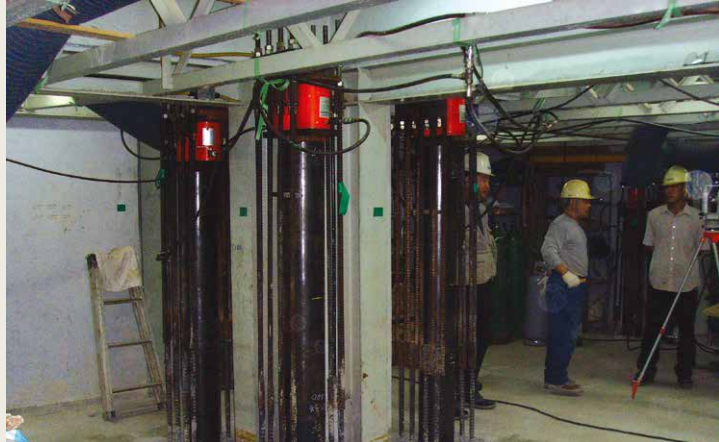
Under construction

The building had slanted more and more until erecting it in 2009 although the ground reinforcement had been executed repeatedly by using cement grouting construction method for 40 years since it was completed in 1969. It slanted to 387mm before erecting it, and its slope was 1/89 and E level. The building was reconstructed with slope of 1/3,500 and A level in 2009.

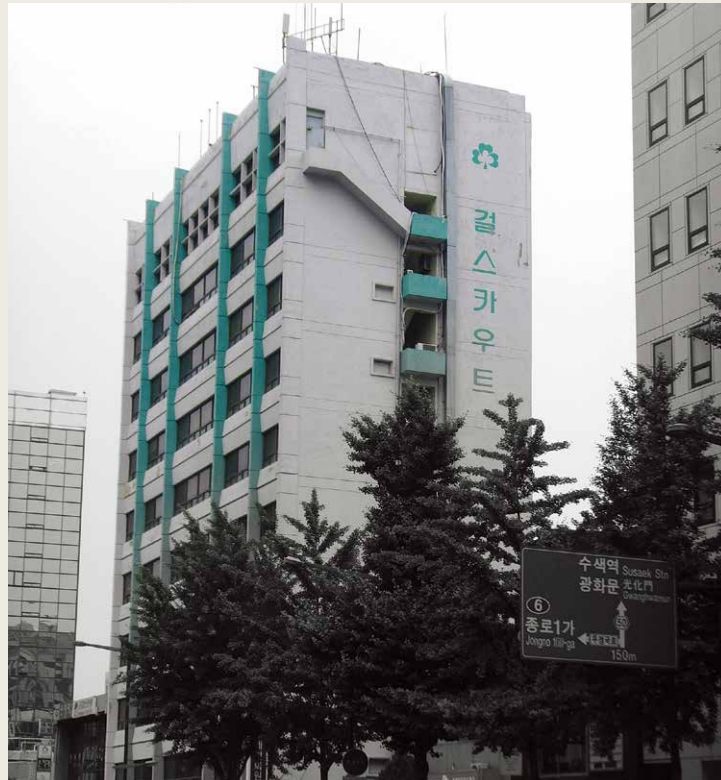
After construction

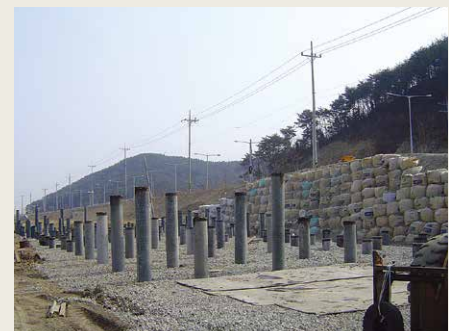
$\phi 216 \times 8t$  reinforcement piles were passed into the firm ground and was installed in the firm ground of  $N=110/30$ . Firm ground Soft ground  $\phi 216$  Steel pipe

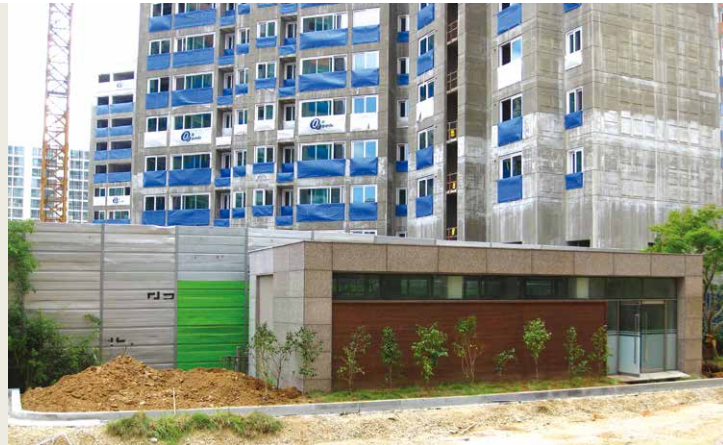
Before construction

The first floor of storage building was reinforced by using  $\phi 50$  micropile, however, occurrence of micropile buckling led to a slope of 1/74 and E level before reconstruction. The minimum rule is to support two times of applied load and to be evaluated by pressure test not tension test because piles support the weight delivered to the foundation. The applied weight in one area of the building foundation was less than 30 ton. In this area, tensile capacity of  $\phi 50$  micropile was more than 100 ton, however, its compressive strength was less than 30 ton. The building with drooping of 160mm was reconstructed upward 145mm with a slope of 1/786 and A level, however, it couldn't be reconstructed more horizontally because the micropile was pulled by rock anchor.

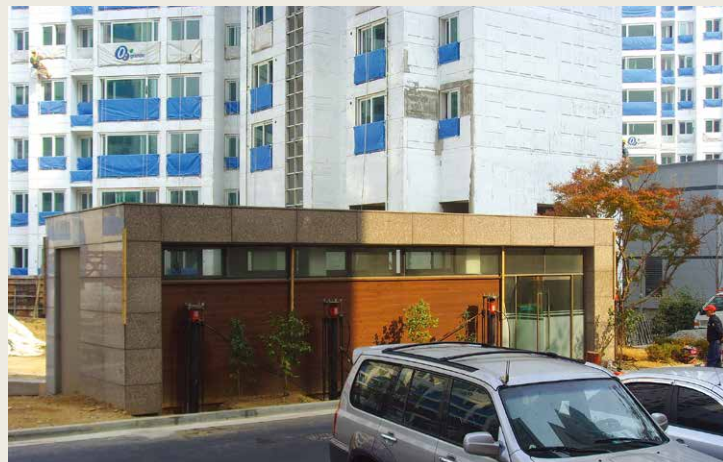
After construction

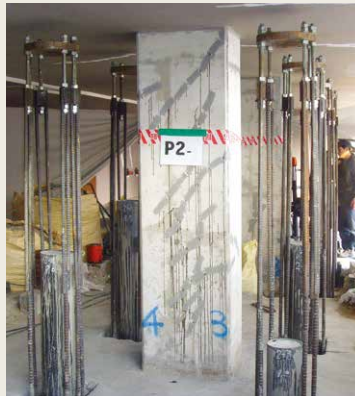
Under construction

An accident was generated from tension cracks in the column whose foundation was not reinforced after 3 years of the first settlement reconstruction. It was a predictable accident from the ground condition of the site long time ago. At this time, seven areas of the foundation were reconstructed. It was finished by using steel sheet and carbon fiber with totally different appearance and texture from adjacent columns. Korea E&C doesn't execute reinforcement work by using carbon fiber and steel sheet through epoxy adhesion. You are not able to identify visually the surface condition reinforced by steel sheet and fiber, however if you tap it, you can notice easily whether the steel sheet is separated from concrete or not.

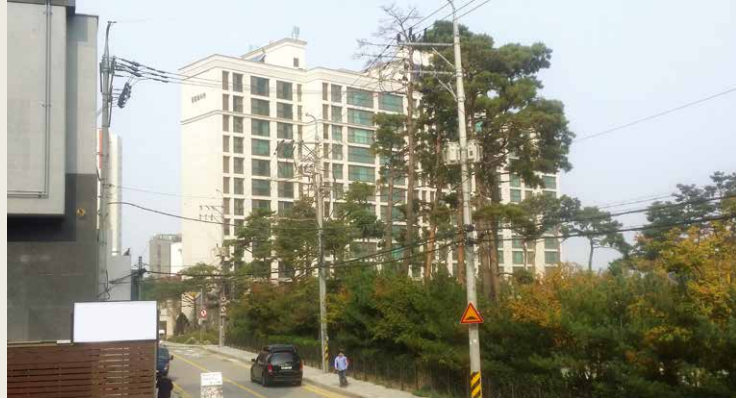
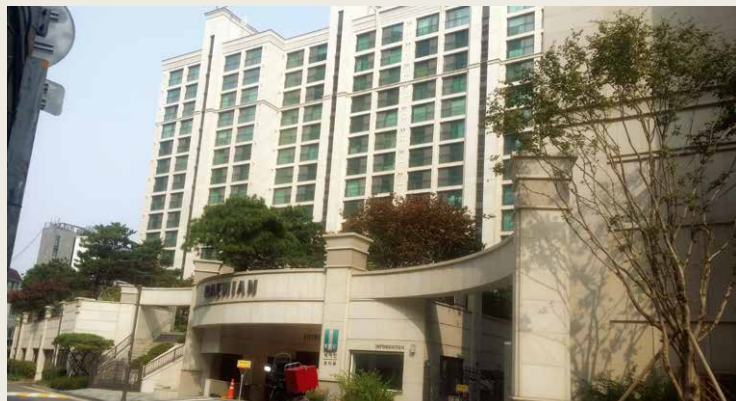
After remodeling of elevator underground extension

The elevator of Cheondam-dong ○○ apartment with one underground level and thirteen stories above ground extended to the 2nd basement level. The previous design to extend the elevator of the apartment was to support the sixteen story existing apartment by using  $\phi 65$  micropile 6 pieces, and to execute the underground extension with excavation. By the way, we found a major problem not to support the building by using the existing installation method of the micropile because the pile was not tension but compressive member of framework. We completed the underground extension by removing the constructed micropile and pressing additionally JP pressed pile.

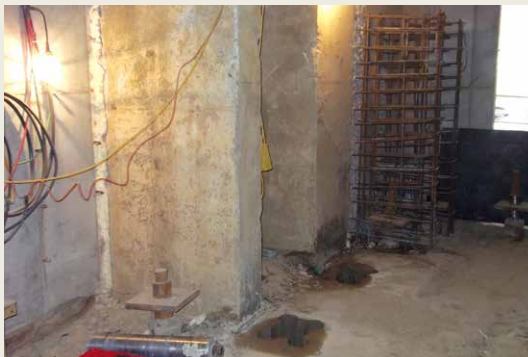
Pressed pile was constructed again due to micropile installation problem.

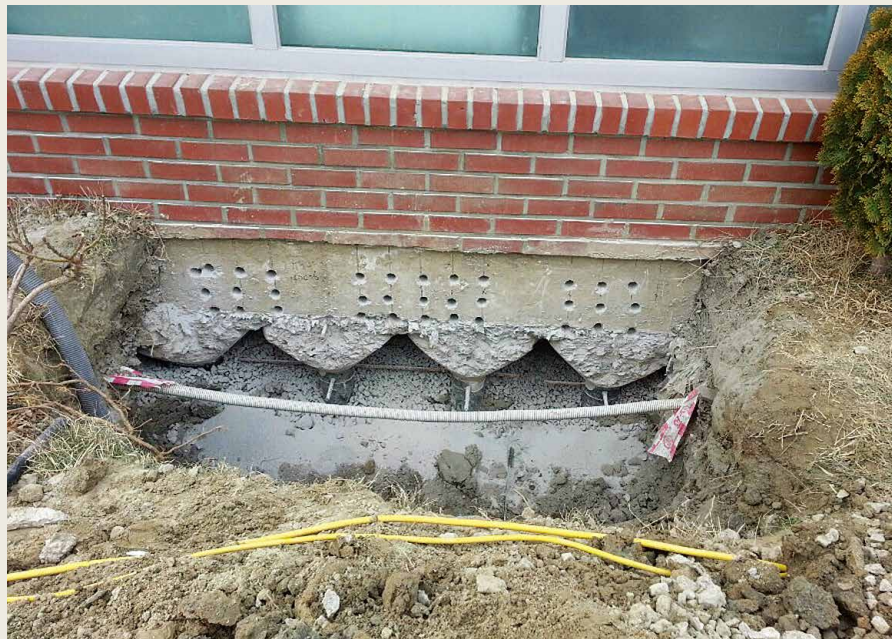
After construction | The settlement was accelerated due to the increase of the weight despite the foundation reinforcement by using top on the soft ground.

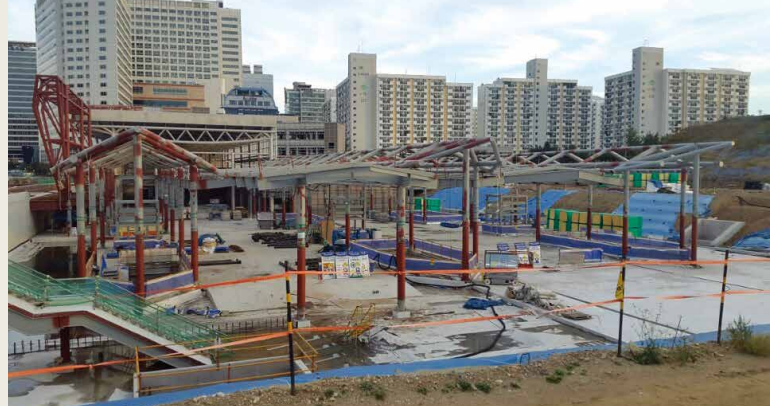
After story height 4.8→7.8m; Raise

The previously designed story height of KTX Suseo station passenger's way (46m×68m) was 4.8m. By the way, passenger's way was in the 1st basement level, therefore, the story height was increased to 3m from 4.8m to 7.8m considering the appearance of the building.

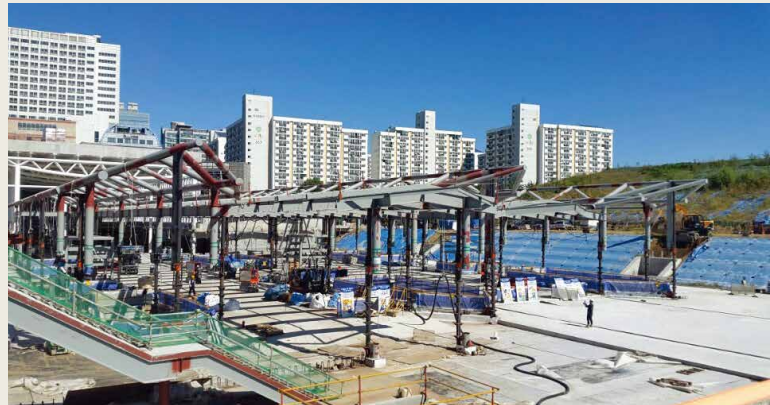
After column cutting 3m and raising

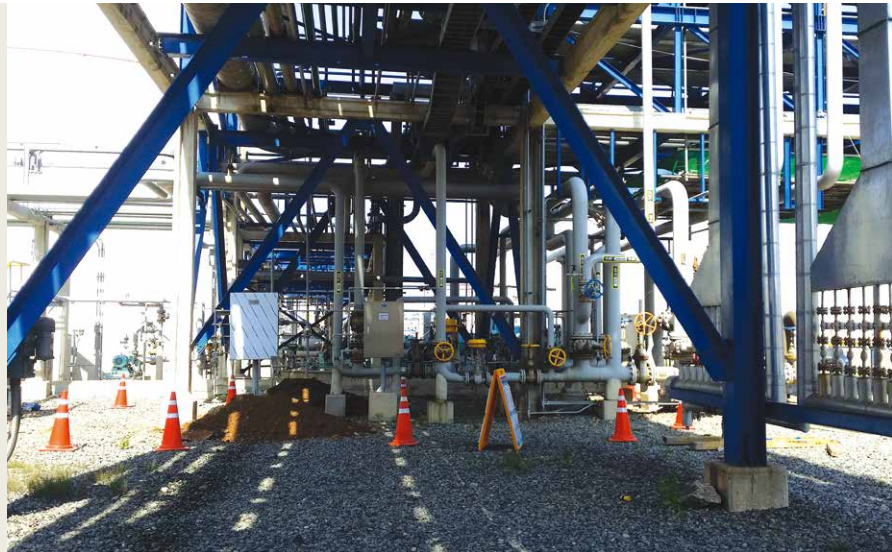
ø400 PHC concrete piles with design capacity of 60 ton in every area of pipe rack column were constructed, however, lack of the capacity was examined due to the increase of facility, and it was reinforced. It was impossible to construct piles by using the existing facility due to previous pipes, therefore, 20 ton piles of 2 pieces were reinforced additionally per one area of the column.

Current status of Pipe Rack Foundation reinforcement location

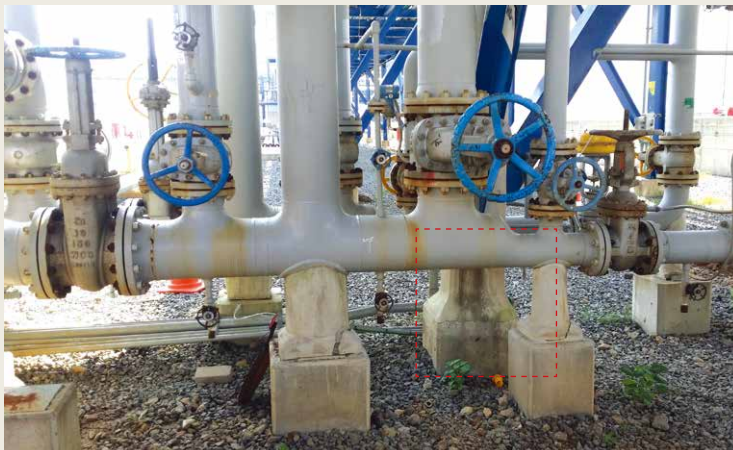
Column foundation reinforcement within dotted line
