# KOREA Engineering & Construction

Beyond safety, Delivering Greater Value,  
Korea E&C, the Integrated  
Reinforcement Science Leader

## Technology Overview

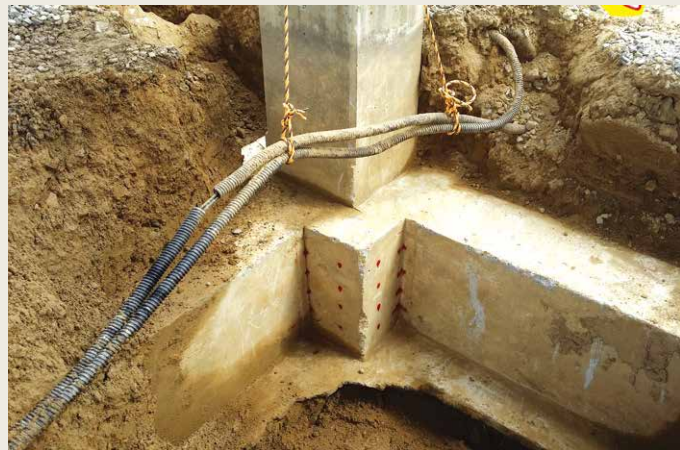
Foundation reinforcement after the increase of the cross section by reinforcing shearing bar

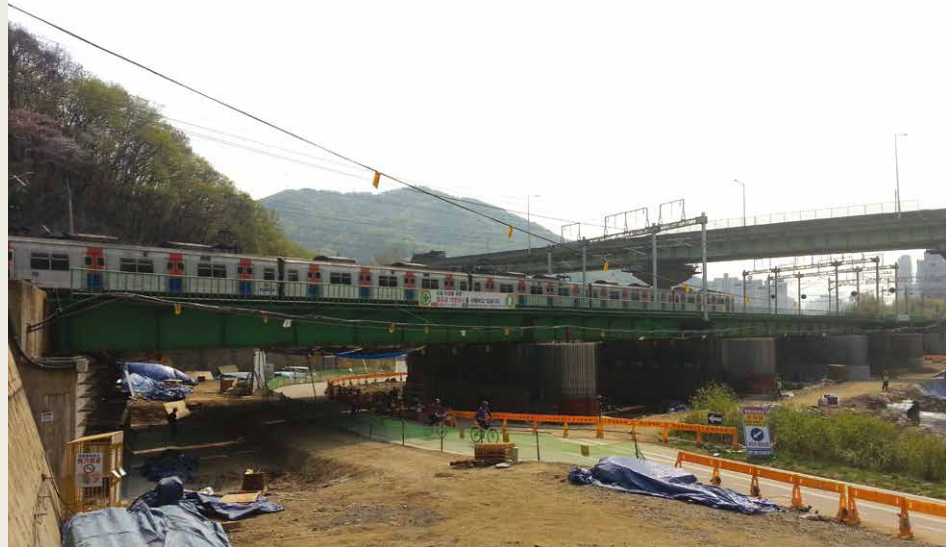
The foundation of the railroad bridge reinforced by measuring and pressing without excavation in the low space and through ø318 steel pipe piles was installed during rail operation.

The front view of Anyangcheon Stream railroad bridge

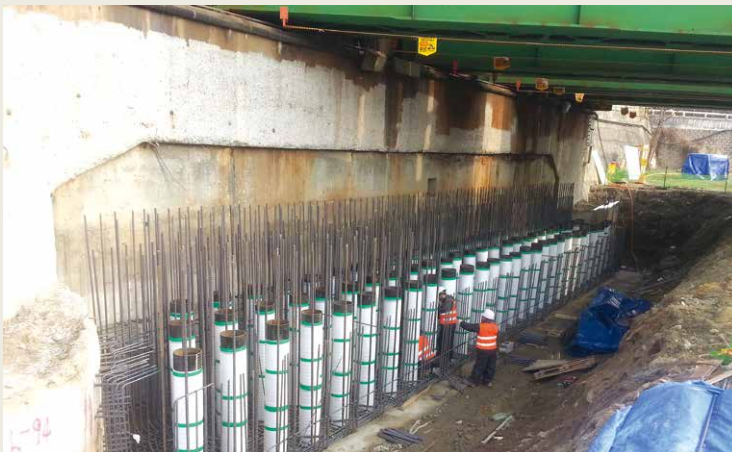
Under construction

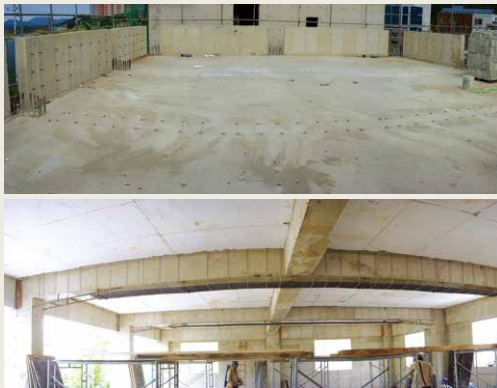
Originally, the beam of Nodae-dong commercial building should have been constructed with width 400m×height 900m, however, it was wrongly constructed with width 400m×height 600m by mistake. which resulted in the difference of 3.375 times, therefore, it was a situation to reconstruct after removal. Upper steel bar of the beam was constructed suitably, therefore, only lower steel bar of the beam was constructed newly to match the height of 900m. Then it was reinforced without removal after placing concrete by applying BT technology which abolishes and binds by using wire rope not to separate old and new concrete.

After construction | Slab top and bottom

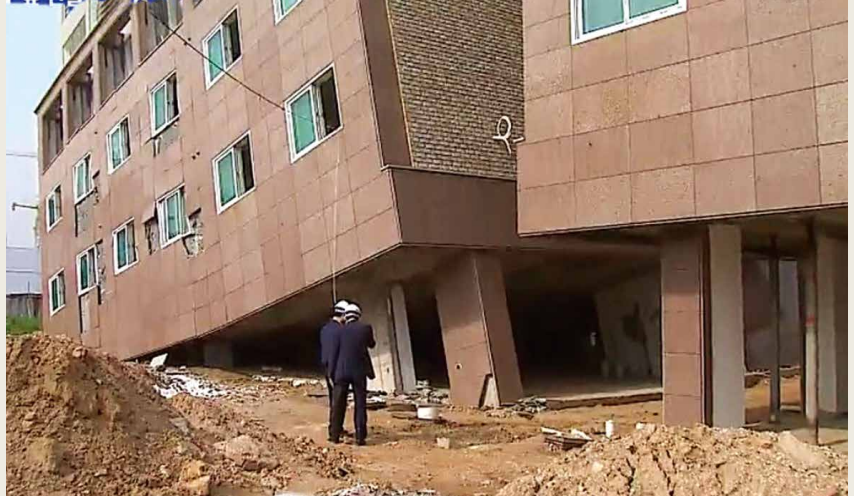
No settlement occurred in the first floor foundation, but punching failure at the column supports caused the structure to tilt.

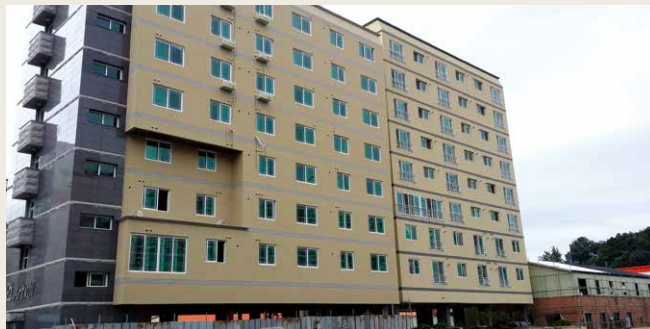
Two buildings are shown distortedly due to column punching settlement.

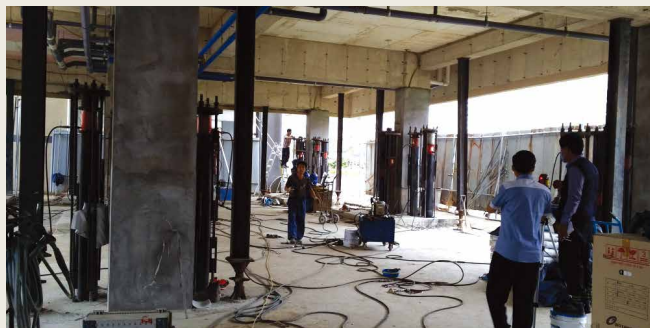
Under punching reinforcement and reconstruction

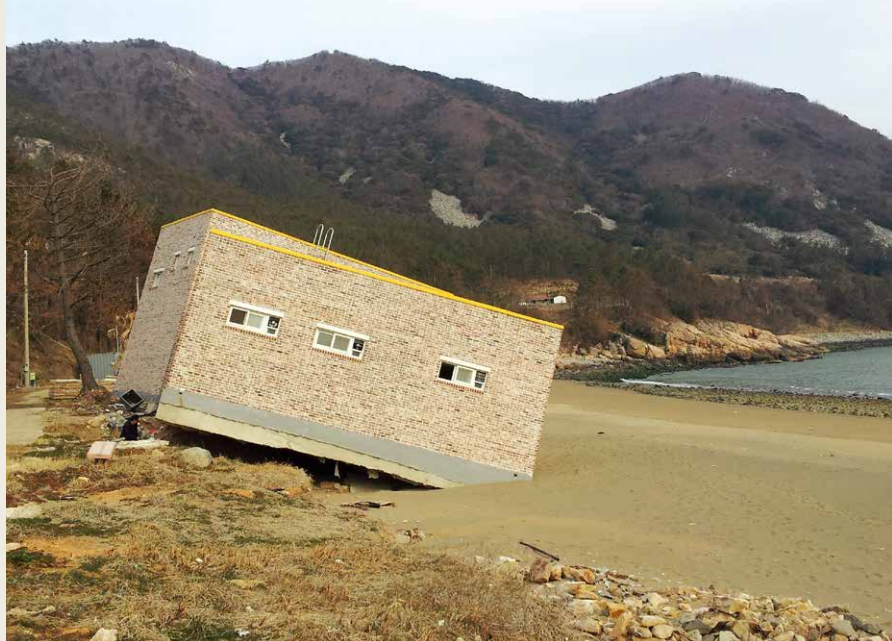
Wando Saengil island beach office building was expected to be removed due to lack of soil in the foundation substructure from typhoon and slanting, however, it was foundation-reinforced by pressing piles and raising 2.5m. Even if soil of the foundation substructure was carried away again from typhoon, it was recreated as a safe building with no worry of slanting again.

Before construction

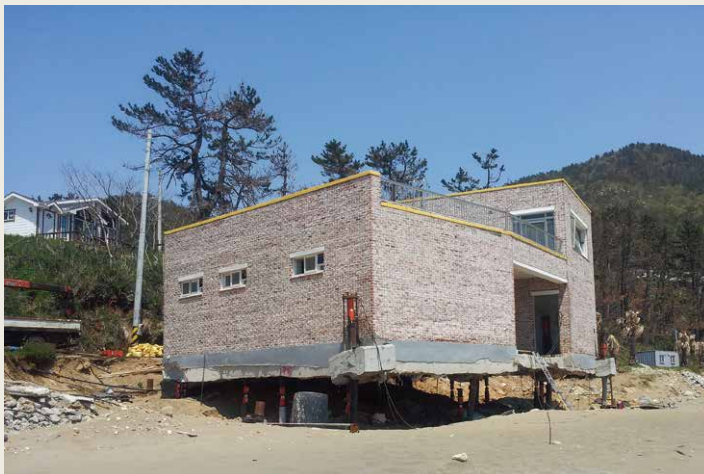
After construction

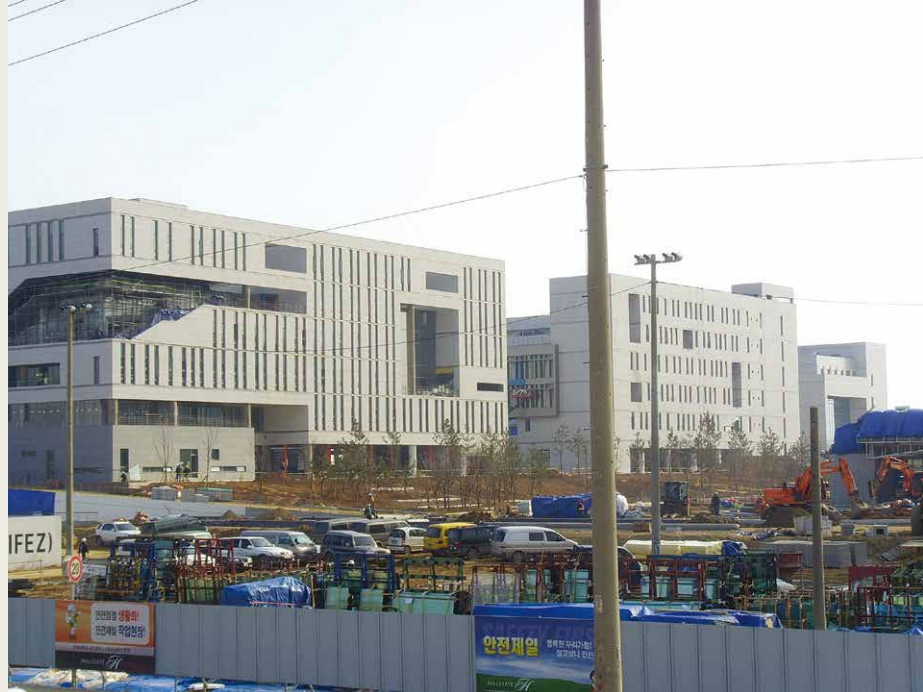
Songdo campus underground up to 15m was very soft ground, however, the firm ground was 20~30m below. The building was built on the concrete piles which were stuck into the firm ground due to the soft ground, and the path between small buildings, joint hole, was built on the paved top foundation with top shape on the soft ground. The building constructed on the piles which were stuck into the firm ground was not settled, however, the joint hole constructed on the top foundation was settled. By the way, the connection part was destroyed because the joint hole couldn't be settled at the area connected the building. It was evaluated that the ground under the top foundation was soft up to 15m despite the top foundation reinforcement on the soft ground, and the weight of the top foundation was added to that of the joint hole, which brought about a result to accelerate the settlement. It was reinforced at the outside of the joint hole because various pipes were installed tightly in the internal joint hole. The joint hole was foundation-reinforced by extending the cross section and by pressing steel pipe piles in order not to be settled in the connection part because the joint hole had no additional foundation.

The front view of building under construction

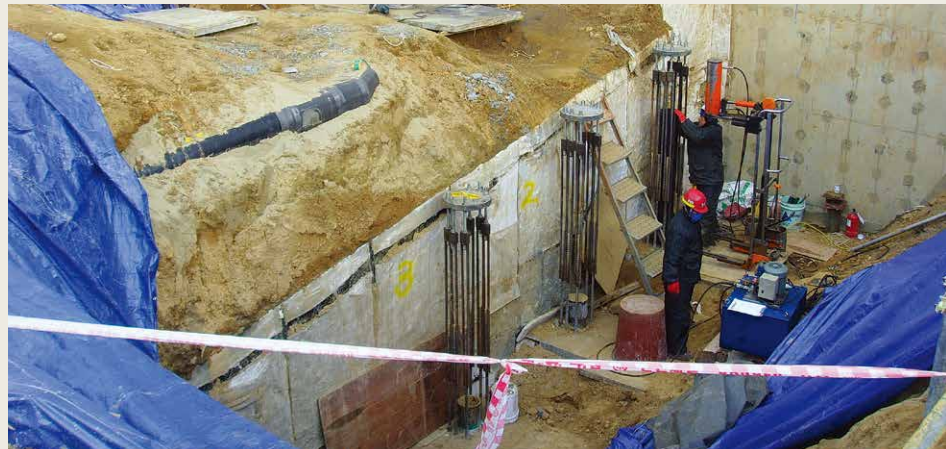
Under construction | top foundation reinforcement, settlement, joint hole, pile, basement reinforcement

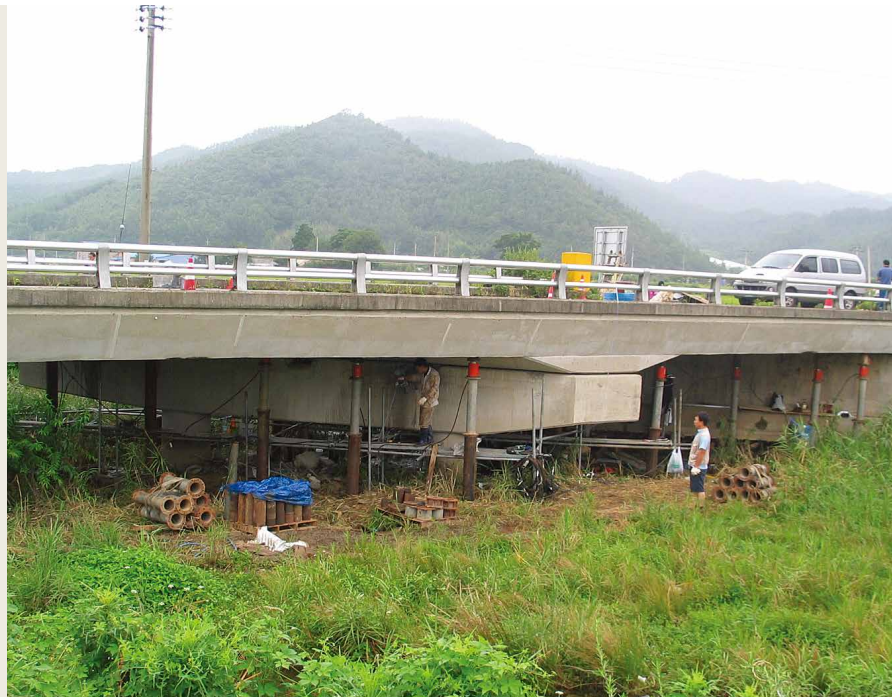
It is a site that it was constructed on the bridge without steel sheet or expansion bridge bearing like the aqueduct bridge, slab was raised, and the rubber support with high elasticity was installed. The bridge bearing was installed after 3 spans slab bridges were pressed simultaneously and raised by utilizing slab weight as reaction, and by utilizing the piles as reaction after pressing piles.

Under construction

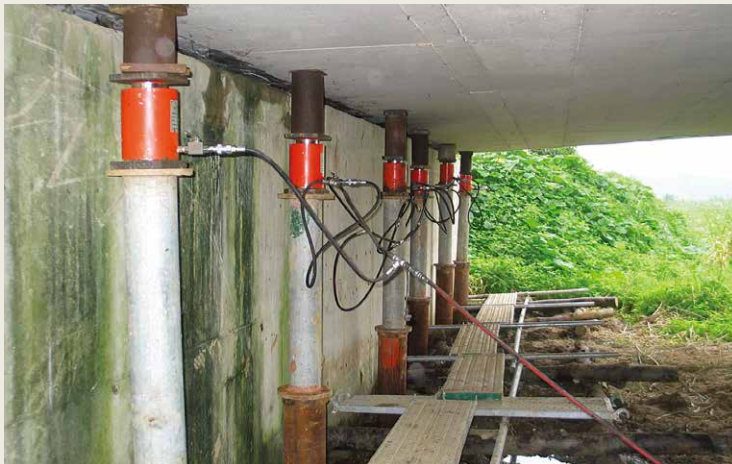
Under construction

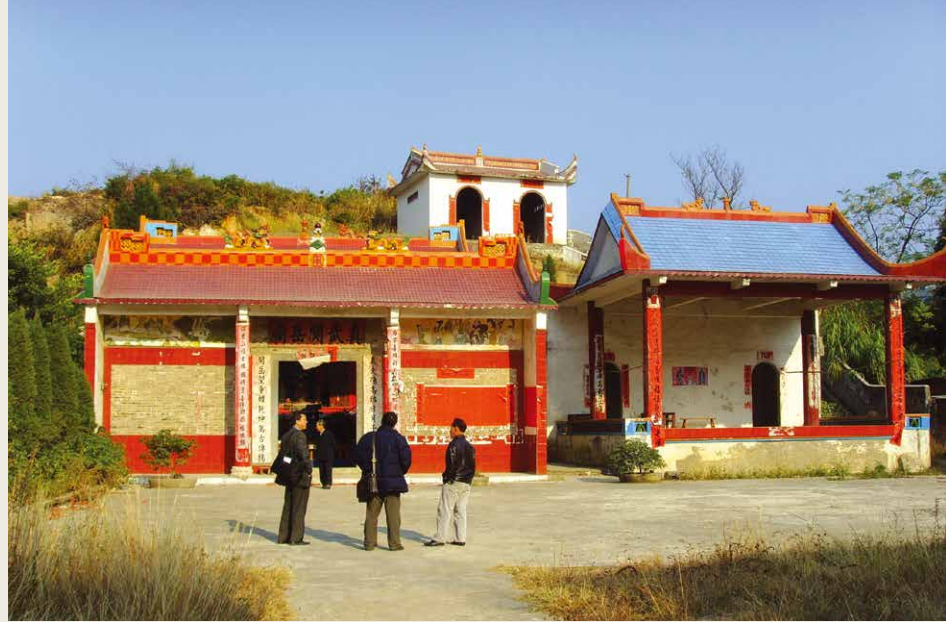
It is a case of 1.3m raise because of flooding occurrence as complex near 'Hyunmoomyo' temple built in Wangojin, Haju-si, Nanning, China was developed. The temple had brick structure on the boulder not concrete foundation, there was a courtyard in the center, and it was extended horizontally with different bottom height. The temple was built 200 years ago, and the culture property had a very difficult condition for raising because its foundation was brick structure on boulder not ferroconcrete structure, there was a courtyard in the center, and it was extended horizontally with different bottom height. It was safely raised with original shape, and the process of raising was aired by Haju TV in China.

Before construction

The world's first 'Boulder-foundation Hyunmoomyo 1.3m raising' Haju TV broadcasted.  
Nanning, China.

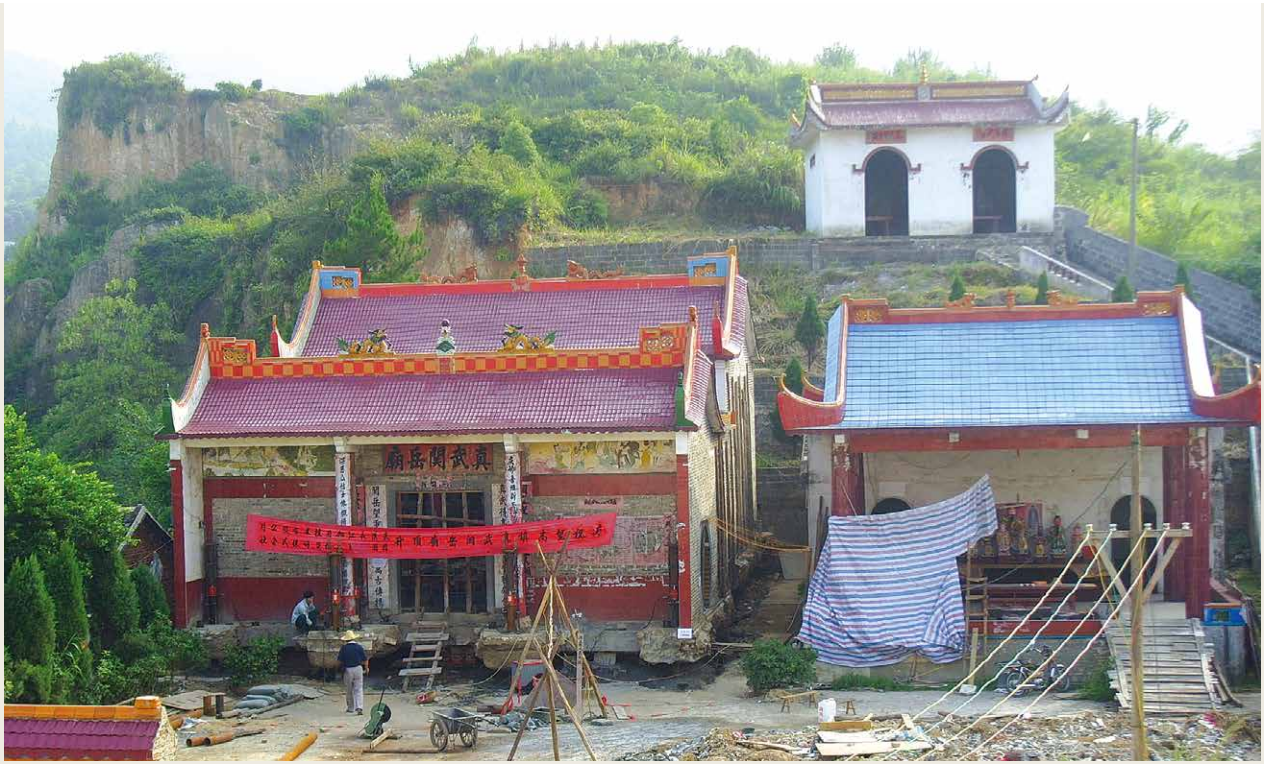
After construction

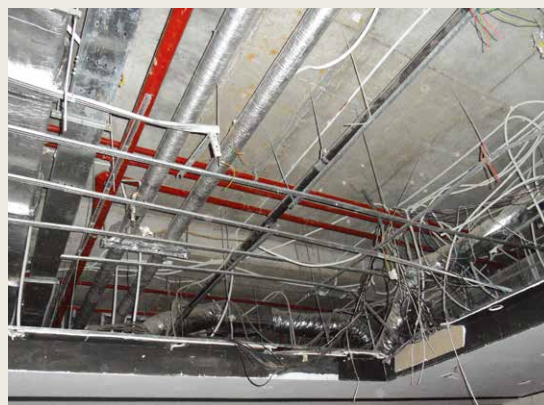
Complicated ceiling of the existing building

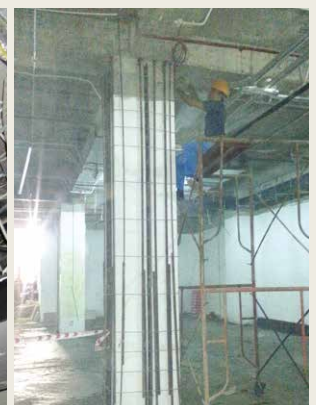
Wire rope binding column reinforcement

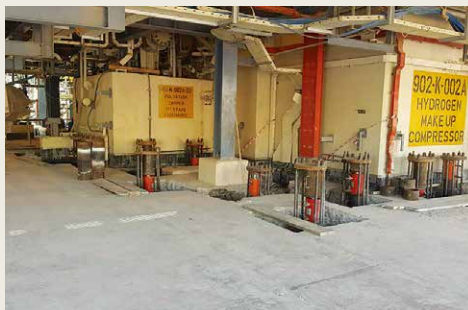
It is a case of settlement reconstruction and foundation reinforcement for oil-refining facility and equipment settled due to sea level rises from global warming and soft ground settlement. Settlement reconstruction and foundation reinforcement were executed without removal of equipment and pipe in the condition that oil-refining facility and equipment were constructed complicatedly, and without pollution near the site. The construction period takes more than one year for foundation reinforcement and replumbing by removing pipe and equipment. However, it had been completed for three months without removal of pipe in the site.

Under construction
